SRS

E-BULLETIN

June 2025

Case Studies

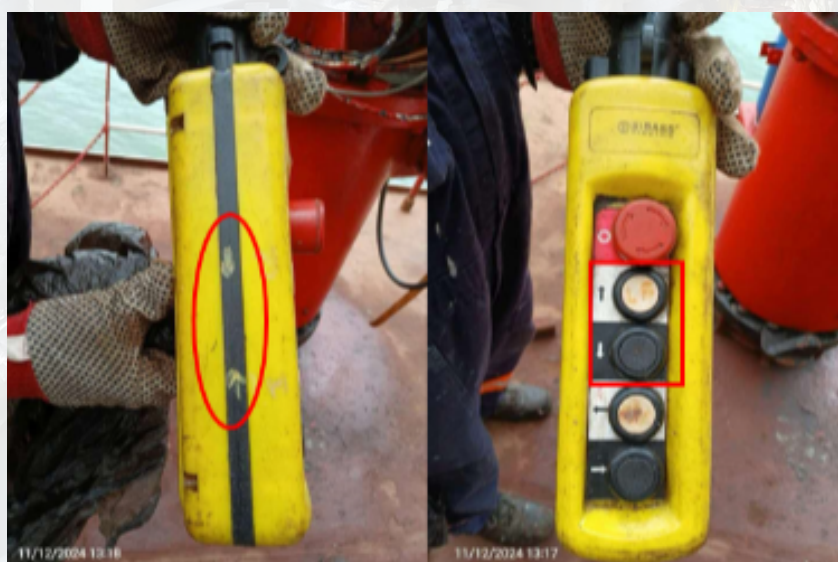
Figure 1

The Bosun and AB attempted to slack the wire from the storage drum using the remote-control unit (see Figure 1). However, contrary to their intention, the wire began hoisting in the opposite direction. They requested ETO to examine the remote control for potential malfunctions.

During the ETO's inspection and testing the remote control, the AB decided to slack the wire manually using the hand crank. Without warning, the motor began rotating violently without load due to the slack wire, causing the hand crank to slip before striking both AB and ETO. The incident resulted in the AB sustaining a fractured forearm and the ETO suffering a head injury.

The electric motor of the rescue boat davit is designed for hoisting operations, not for lowering the lifeboat. Instead, rescue boat davits employ a gravity-based lowering system, whereby the rescue boat descends under its own weight, regulated by a brake mechanism. This design specification is clearly documented in the manufacturer's instruction manual.

The incident revealed that the team lacked the requisite seamanship skills, knowledge and experience in operating this mechanism. Furthermore, the preliminary toolbox meeting proved inadequate of risk assessment in establishing and communicating the correct procedure and task to be carried out.

The remote-control unit in operation featured "Up" and "Down" buttons, which was inappropriate for this system and potentially misleading. This unsuitable control device appears to have been inherited during the management transition, during which time its inherent safety risks went unidentified.

Investigation revealed that the limit switch had malfunctioned, failing to perform its critical safety function of interrupting the electrical power supply when the hand crank was engaged with the cranking post.

Rather than waiting for the ETO's resolution of the remote control, the AB initiated manual cranking operations. This simultaneous execution of conflicting work processes failed to trigger any safety concerns among the three team members present. This incident highlights a lack of safety awareness within the team.

This incident resulted from a combination of technical failures and human factors. The primary contributing factors included improper equipment, mechanical failure (faulty limit switch), inadequate procedural knowledge, and poor safety awareness. The absence of proper safety protocols and insufficient team communication significantly elevated the risk of injury. Most critically, the fundamental misunderstanding of the davit's designed operating principle—using gravity-based lowering rather than motor-powered descent—underpinned the entire sequence of events leading to the accident.

To prevent future incidents, a structured programme of crew training and competency assessment should be established, supported by enhanced safety protocols linked to the machinery / equipment to be used, proper documentation, and regular maintenance schedules, with particular emphasis on the gravity-based lowering system's correct operation.

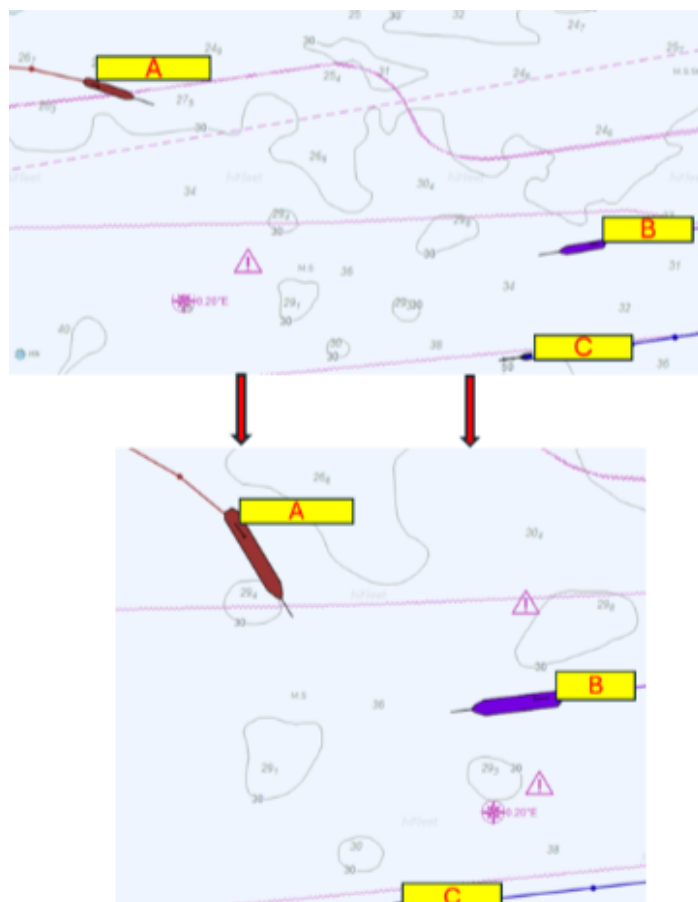
Figure 1

Vessel B reduced speed to adjust its Estimated Time of Arrival (ETA) at PEBGC, during which Vessel C overtook it on the port side. At this time, Vessel A’s intention was to follow Vessel B’s stern, adjusting its heading for crossing the TSS. However, as Vessel A drew closer to Vessel B, it made a significant starboard alteration.

Analysis suggests that Vessel A's bridge team mistakenly tracked Vessel C's path to cross the TSS instead of Vessel B. When Vessel C completed its overtaking of Vessel B and became visible to Vessel A, the bridge team lost situational awareness of Vessel B's position and shifted attention from monitoring Vessel B to following Vessel C's stern for the TSS crossing (see Figure 1).

The bridge team on Vessel A consisted of the Master, Officer of Watch (OOW/Second Officer), and Helmsman, which was at manning level 3. During the pilot disembarkation, the Second Officer escorted the pilot to the ladder, temporarily reducing the bridge team to level 2, with no dedicated lookout maintained.

The collision's primary cause was attributed to the absence of a proper lookout on both vessels. The Masters and OOWs failed to maintain adequate situation awareness of the developing close-quarter situation. The master of Vessel A, without conducting a comprehensive assessment, attempted to cross the TSS while following an incorrectly identified vessel. Simultaneously, Vessel B's bridge team failed to properly evaluate the crossing situation and did not detect Vessel A's change in aspect at close range. Critically, there was no monitoring or assessment of Vessel A's movement.

The collision between Vessel A and Vessel B resulted from a combination of poor bridge team management and inadequate situational awareness. The temporary reduction in bridge manning during pilot disembarkation, coupled with the failure to maintain proper lookout, led to critical errors in vessel identification and traffic assessment for Vessel A. Vessel A's bridge team's misidentification of the vessel to follow, and Vessel B's failure to monitor the developing situation, ultimately resulted in the collision.

To prevent recurrence, it is recommended that:

- Bridge teams maintain minimum safe manning levels at all times (in accordance with its safety management system), particularly during critical operations
- Proper lookout be maintained through dedicated personnel and effective use of all available means
- Bridge teams verify target vessel identification before executing course alterations
- VTIS advice be acknowledged and followed, especially during TSS crossings
- Regular training be conducted on maintaining situational awareness in dense traffic situations

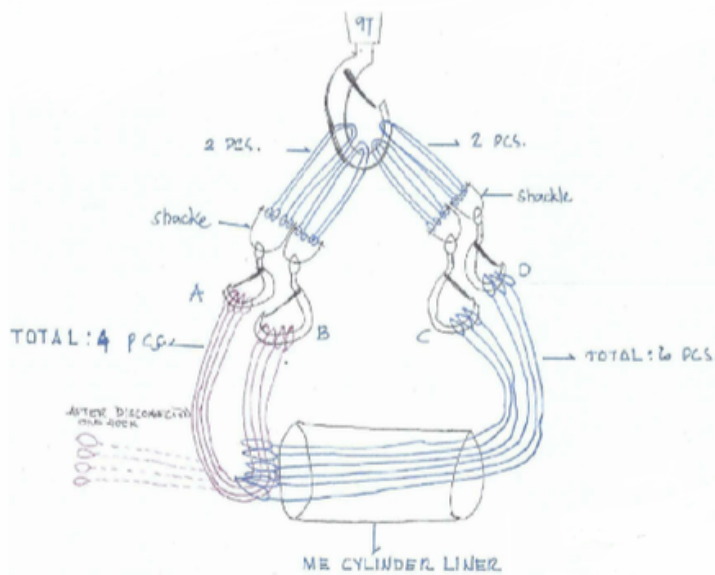
Figure 1

When the liner was landed on UV's deck, it was not properly secured (i.e. no precautions were taken to ensure that it would not move at all). Despite not securing the liner properly to prevent movement, UV's crew released the lifting equipment (see below Figure 1).

UV's crew prematurely removed the slings from hooks 'A', 'B' or 'C and D' before the liner was properly secured on deck to prevent movement.

Based on the information gathered, it was deduced that UV's crew had not carried out correct procedure in relation to securing heavy load on deck.

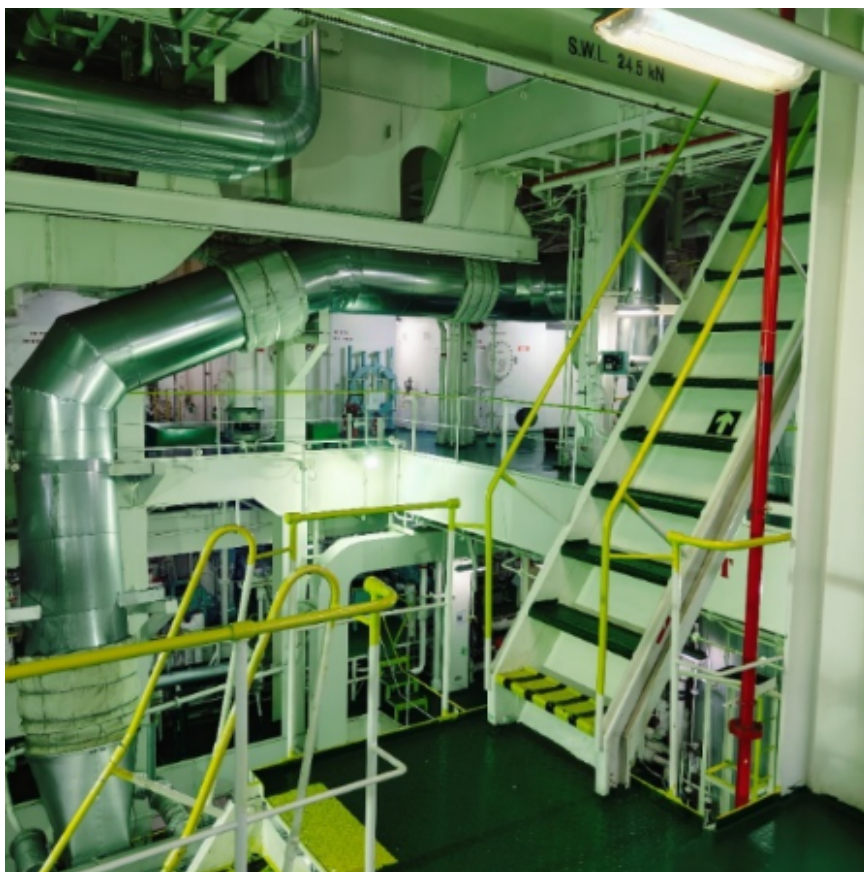
The injured crew was standing at the engine room incinerator platform, which was at the same level as the Engine Control Room; see image below:

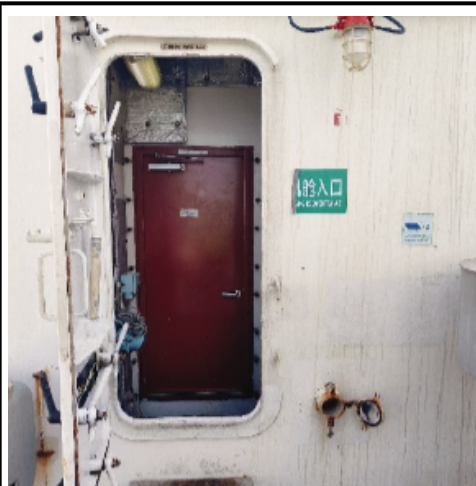
The vessel had failed to implement security measures as required by the Ship's Security Plan (SSP) and Company's Security Circulars. The steering gear door was left open (see Figures 1, 2, 3 and 4 below).

Figure 1:
Steering gear room access door
was left opened

The shipping community is reminded to ensure shipboard compliance of the SSP and consider heighten precautionary measures at identified risk areas where occurrences of unauthorised boarding are known.

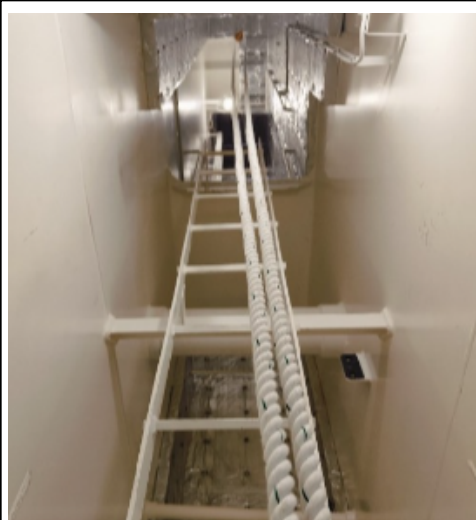
Figure 2:
The engine room escape trunk
used by the intruders.

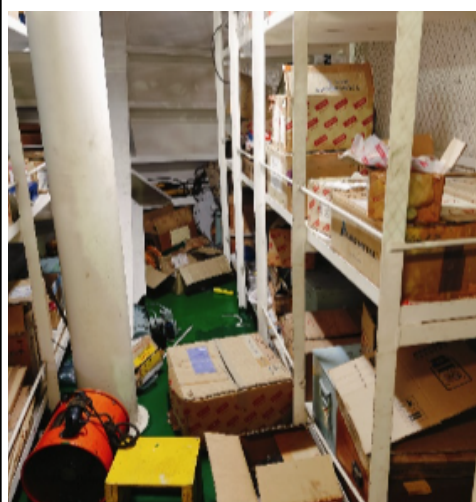
Figure 3:
Engine Room Store where engine
parts were taken by the intruders.

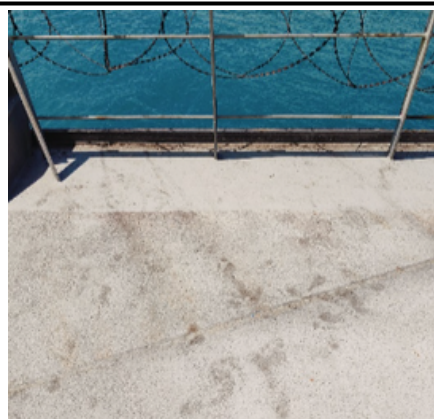
Figure 4:
Intruders' footprints on starboard
quarter.
Note: Razor wire was rigged only
after the incident.
