Exhaust Gas Cleaning System (Scrubber)

An Advisory for Singapore-Registered Ships

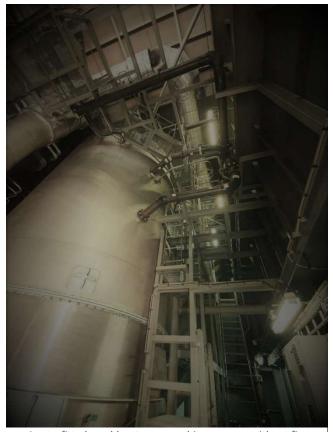
The majority of scrubber installation involve having the scrubber within the engine room. For new built vessels, the fire protection arrangements for the scrubber compartment would likely to have been integral with the engine room.

However, for retrofit cases, consideration would be required for extension of the existing fire detection system or a new separate fire detection system itself, for the additional scrubber compartment.

Similar to the fire detection system, for retrofit cases, consideration would be required for extension of the existing fixed-fire extinguishing system for the additional scrubber compartment. Calculations would need to be carried out by the shipyard/class and the capacity of the existing fixed fire-extinguishing system may need to be increased. For example, if the ship was using fixed CO2 fire-extinguishing system, such works would involve increasing the number of CO2 bottles and extending the CO2 piping and nozzles into the scrubber compartment.

A retrofitted scrubber tower machinery space without fire detection nor fixed fire-extinguishing system.

Aside from the fixed system, portable extinguishers, fire hydrants, hoses and nozzles would also need to be provided. Where ventilation flaps/dampers are fitted to the scrubber casing, remote closing arrangements should be provided. Please see SOLAS Chapter II-2 Regulation 10.

The Fire/Safety Control Plan needs to be reapproved. Please see Case Study 1.

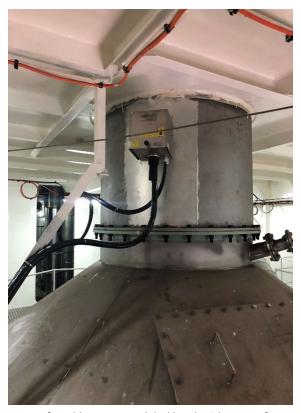
However, it was observed during our Port State Control inspections on board that there are retrofitted installations without any provision of fire detection systems nor fire-fighting arrangements. Some photos to illustrate the absence of such provisions are appended for information.

Top of scrubber tower and deckhead, without any fire detectors nor fixed fire-extinguishing arrangement

In this instance, the owners were advised to consult Class and Flag Administrations so that the appropriate corrective actions could be taken.

Modifications to provide new or extend the existing fire detection system and fixed fire-extinguishing system to the additional space would be costly, time-consuming and disruptive to the ship's operations. As such, it is advisable to consider this aspect in the design and planning stage.

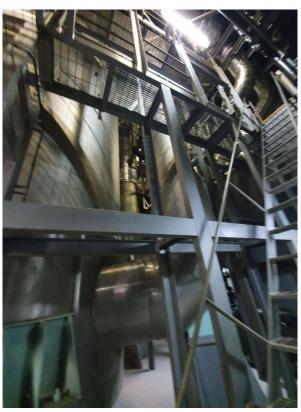
Another scrubber tower machinery space without fire detection, fixed fire-extinguishing system or portable fire extinguishers

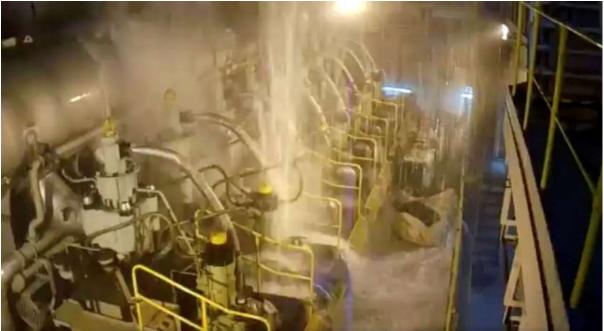
A one-minute video recently surfaced in social media with the title "Ship scrubber system failure causes flooding of Engine Room". The video showed copious amount of water cascading down from the deck head of the engine room onto the main engine platform. There were alarms sounding in the background and the crew could be seen rushing about trying to address the situation. No further details were provided as to the name of the ship nor the date and time of this occurrence; hence, the authenticity of this video could not be verified.

Nevertheless, it is indeed very plausible that such a failure may occur on board ships fitted with scrubbers. There was no indication of the ship's operational status at the time of the incident in the video. However, should such a failure of the scrubber or pipework integrity occur while the main engine or boiler is running, it is possible that aside from the danger of being flooded, the engine room may also be inundated with exhaust gas as well, making it very difficult for the crew to respond. Furthermore, should such a failure occur while the ship is manoeuvring in heavy traffic, a hazardous navigational situation would quickly develop. It is imperative that the structural integrity of the scrubber and associated pipework is constantly checked for signs of leakage or corrosion.

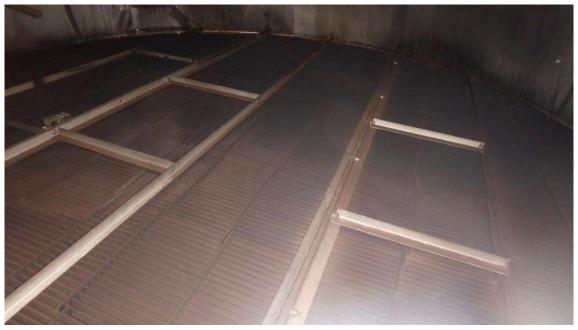
Demister section that is prone to soot build up when scrubber is run dry

It is advisable to establish a regular inspection schedule of the scrubber internals, and cleaning of the internal components such as packing or demisters to prevent blockage and accumulation of soot. Such accumulation of soot may carry a risk of soot fire when the scrubber is run dry. Crew should ensure that fixed cleaning arrangements (water or steam, where fitted) are working properly and utilised regularly. Such cleaning should be carried out as per the manufacturer's guidance. The crew should also consider flushing the scrubber for a prolonged period after each scrubber operation to wash down soot, bearing in mind washwater discharge standards in case of open-loop scrubbers.

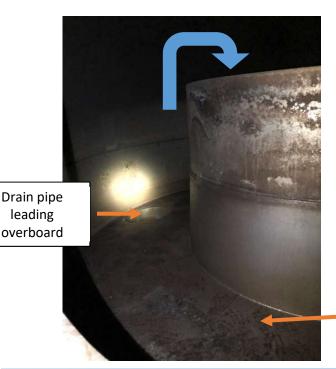
High level sensors

- The overboard valve could have been closed.
- The high water level sensors that were part of the scrubber safety system and supposed to automatically stop the washwater pumps, did not activate when the high water level was reached.
- The seawater pumps continued to supply seawater to the scrubber unit causing washwater to overflow from the scrubber space into the main and auxiliary engines through the exhaust piping.

Wash water accumulated in this space and overflowed from scrubber space back to exhaust piping

This incident highlighted the importance of maintaining the automation and safety system of the scrubber in good working order and are frequently tested, as failure may result in serious consequences.

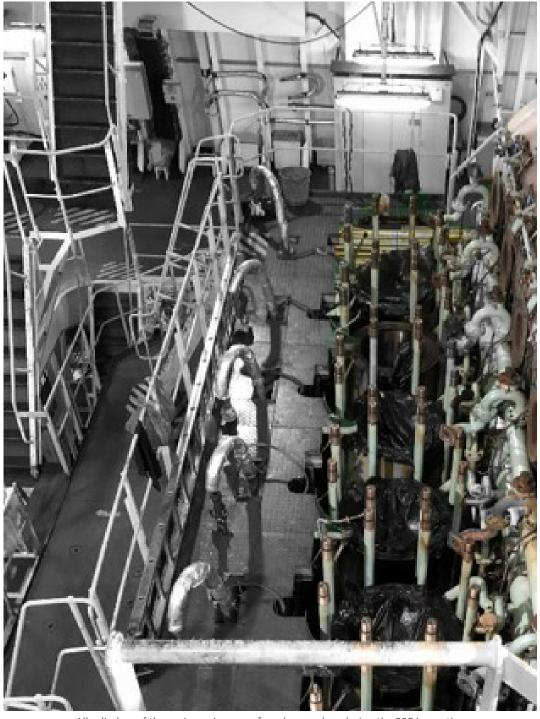
The incident caused severe damages to the main and auxiliary engine components, affecting the turbochargers, cylinder heads, pistons and liners. The crankshaft bearings were also removed for inspection. The vessel stayed in port to complete the repairs and subsequently departed around three weeks later.

All cylinders of the main engine were found opened up during the PSC inspection
