E - BULLETIN

Table of Contents

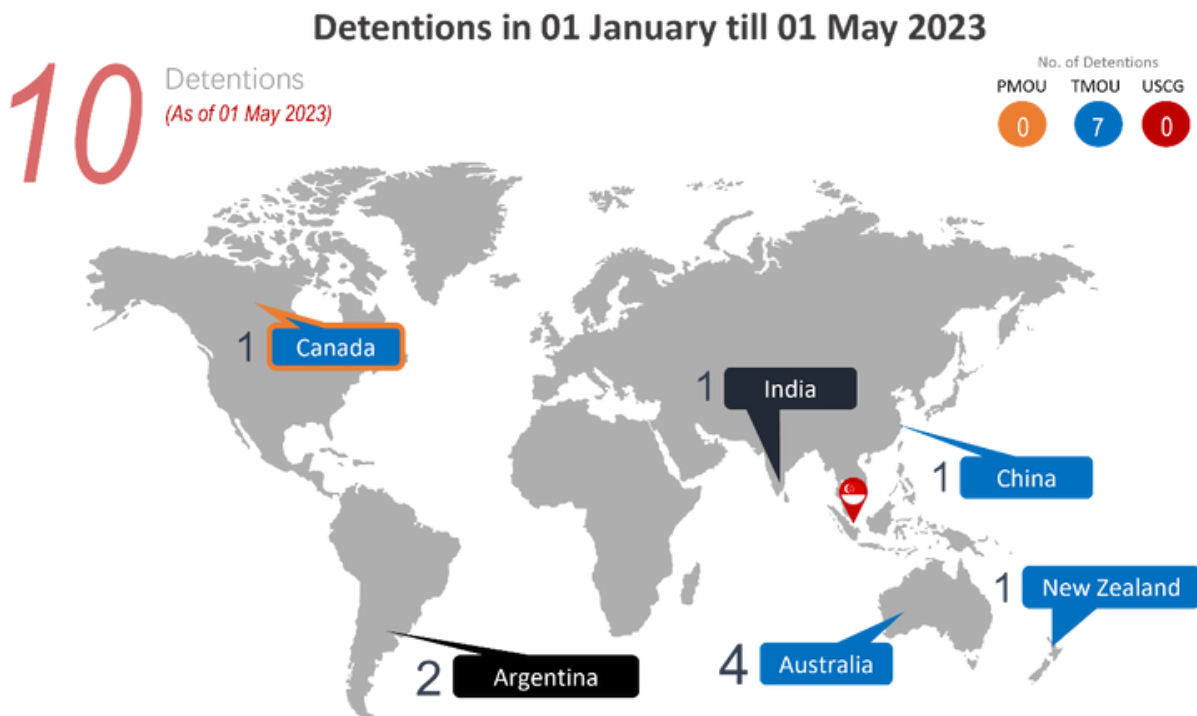
Thus far, 10 SRS were detained under Port State Control (PSC). Notably, 7 detentions were under TMOU of which 4 of those detentions were concentrated in Australia. Under the PMoU, no SRS were detained. There were no detentions by USCG.

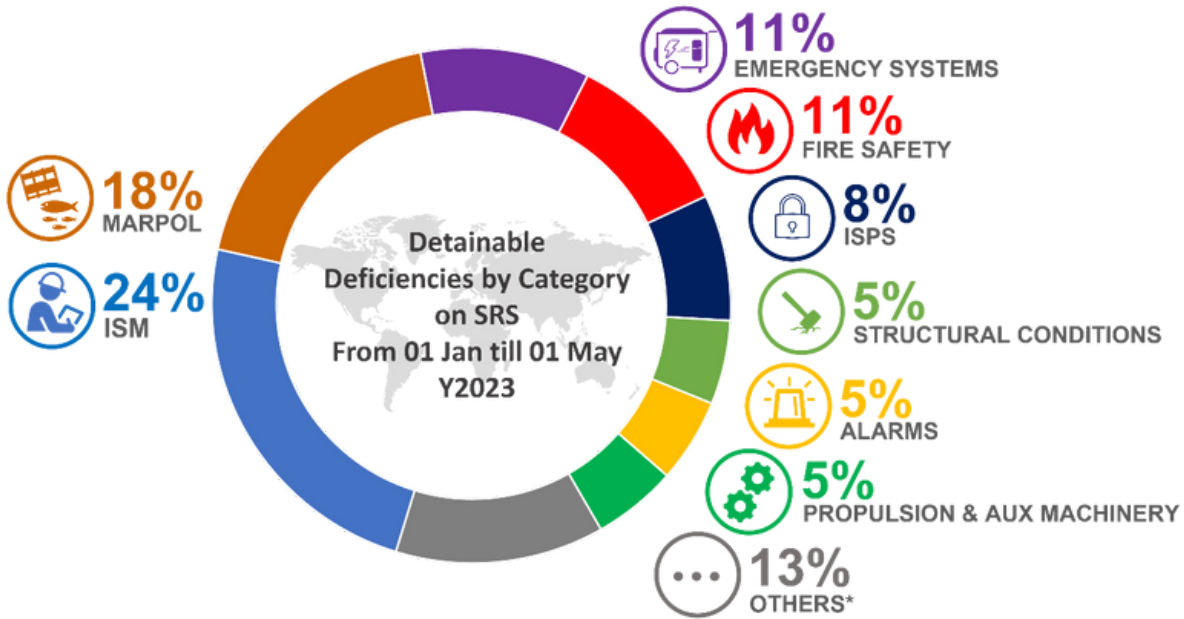
Others include categories such as MLC, safety of navigation, lifesaving appliances, certificates and documentation, water/weathertight conditions, etc.

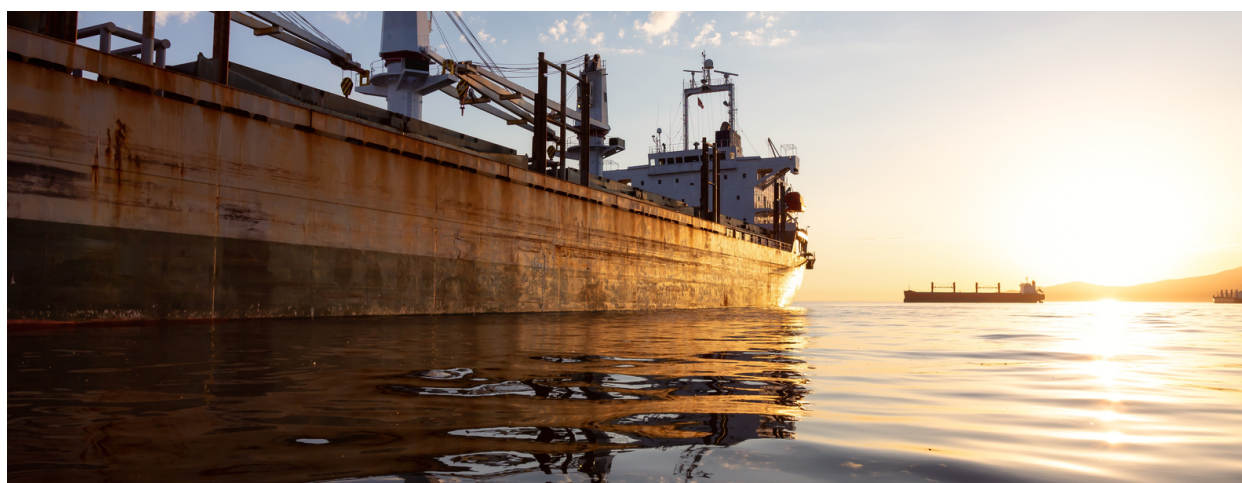
Beginning late 2022, MPA noticed an increased number of Port State Control (PSC) deficiency in relation to Singapore’s MSMD for not reflecting the cook rank. MPA remain guided by the principle that the MSMD is issued under the provisions of SOLAS regulation V/14 and the IMO Resolution A.1047(27). It lays out the required minimum safe manning (of deck officers, marine engineer officers and deck and engine ratings or GP crew) for the ship to be operated safely, securely and the environment protected. It does not include consideration for cooks and crew in the catering department which are required under the Maritime Labour Convention (MLC).

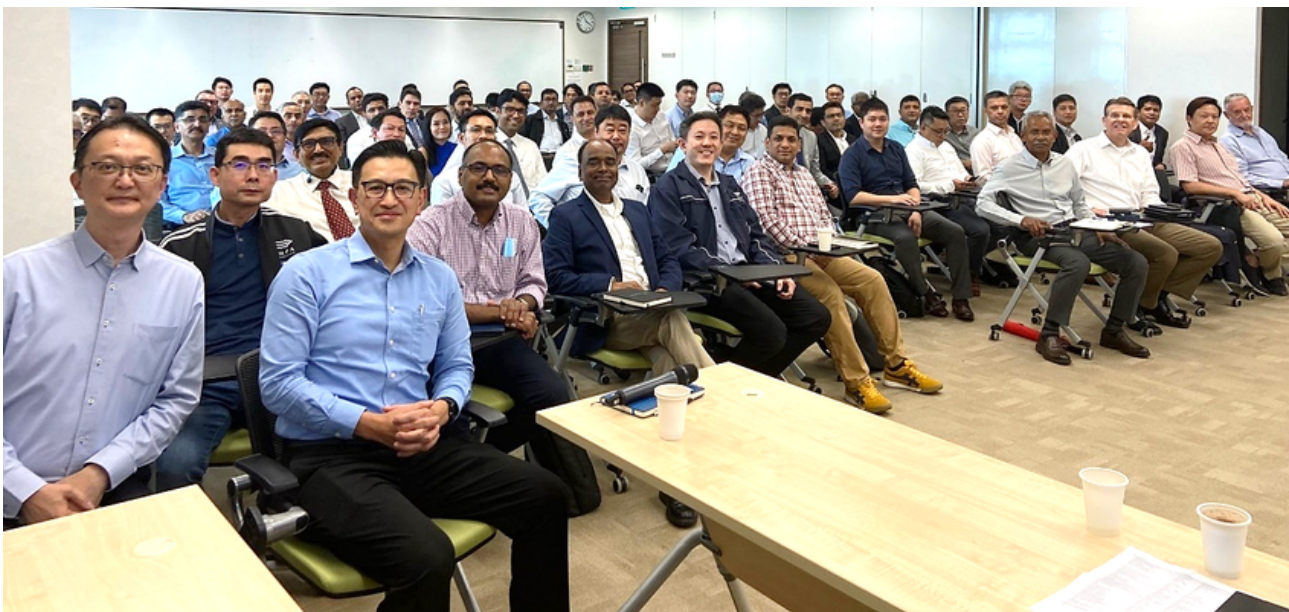
Fig 1: Round table discussion held on 15 February 2023

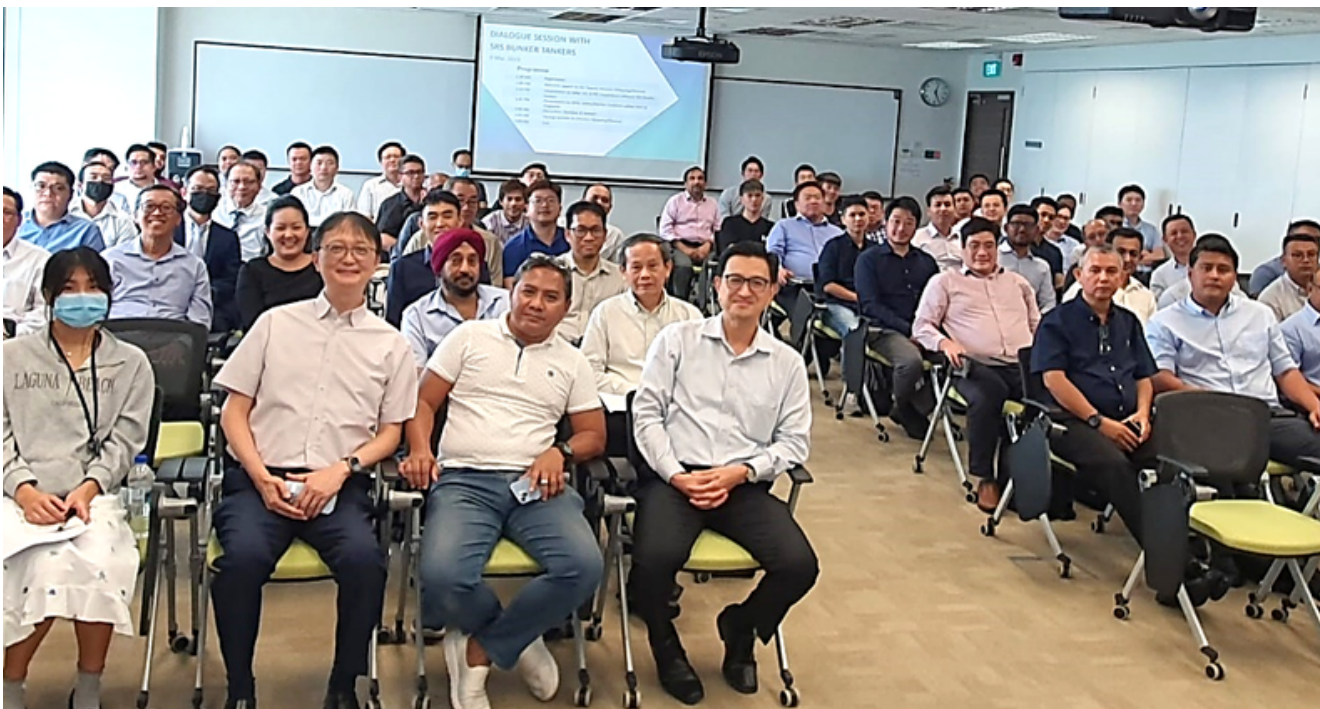
Fig 3: Photo taken at the dialogue session

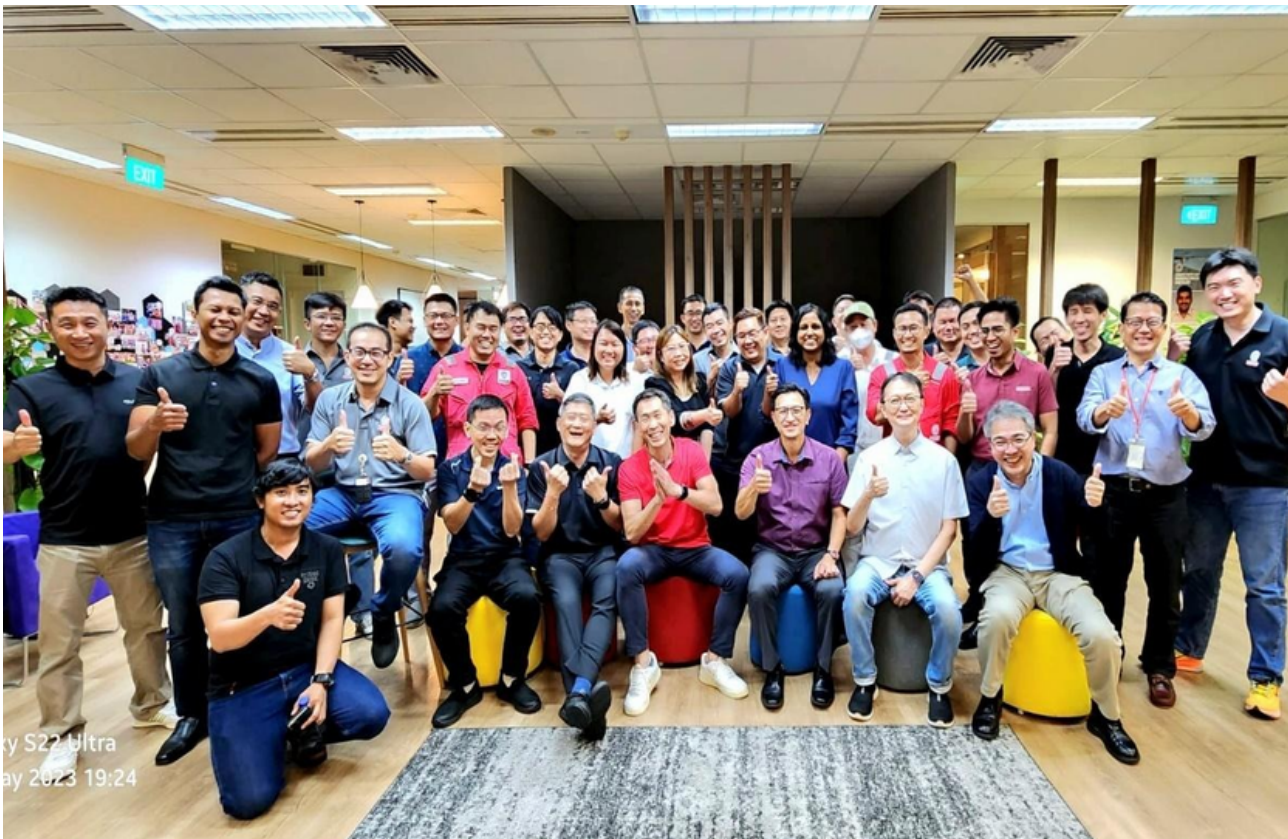
Fig 1: Group photo of BV staffs and MPA officers

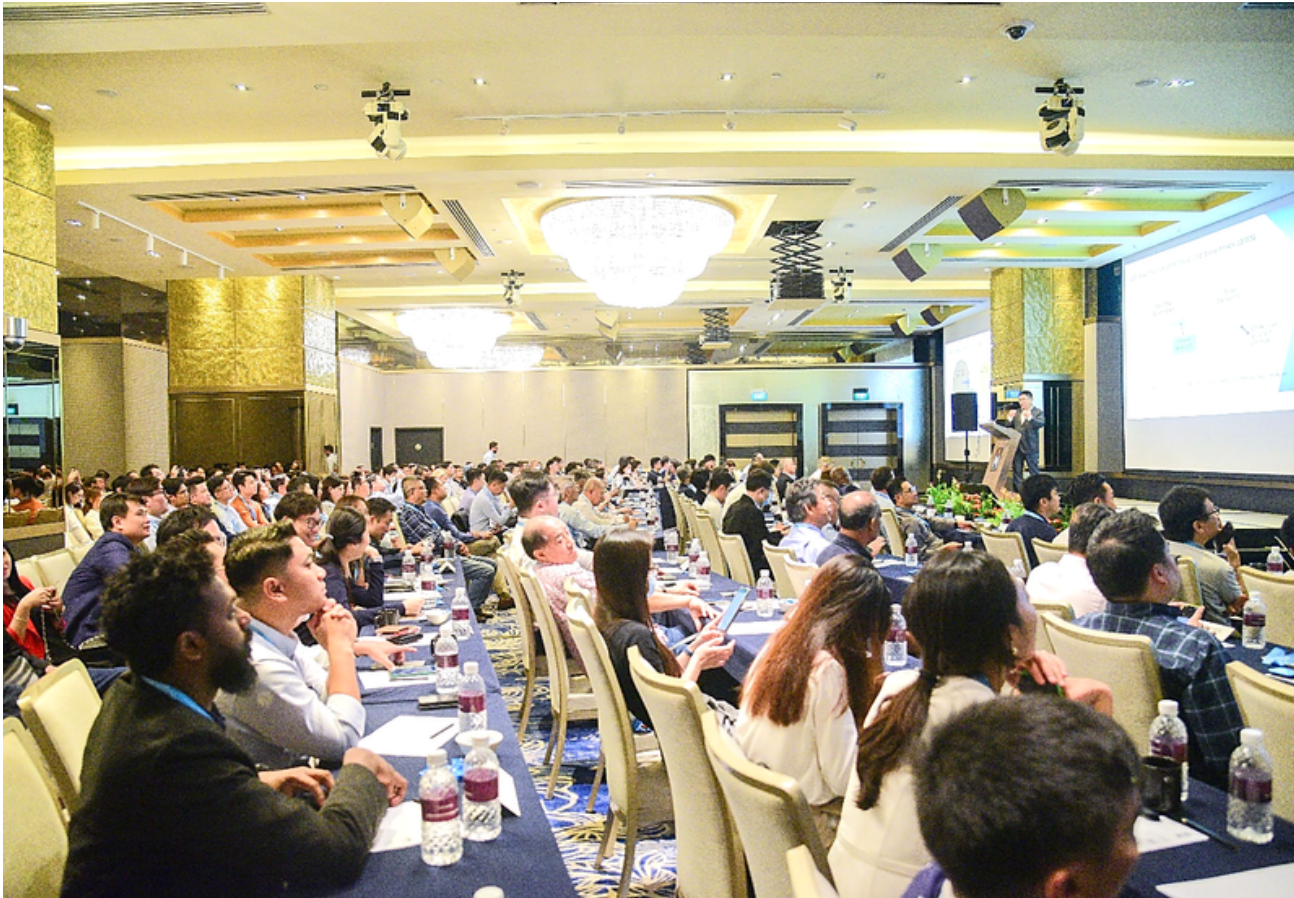
Fig 1: Event photo Marine Fuel Forum 2023

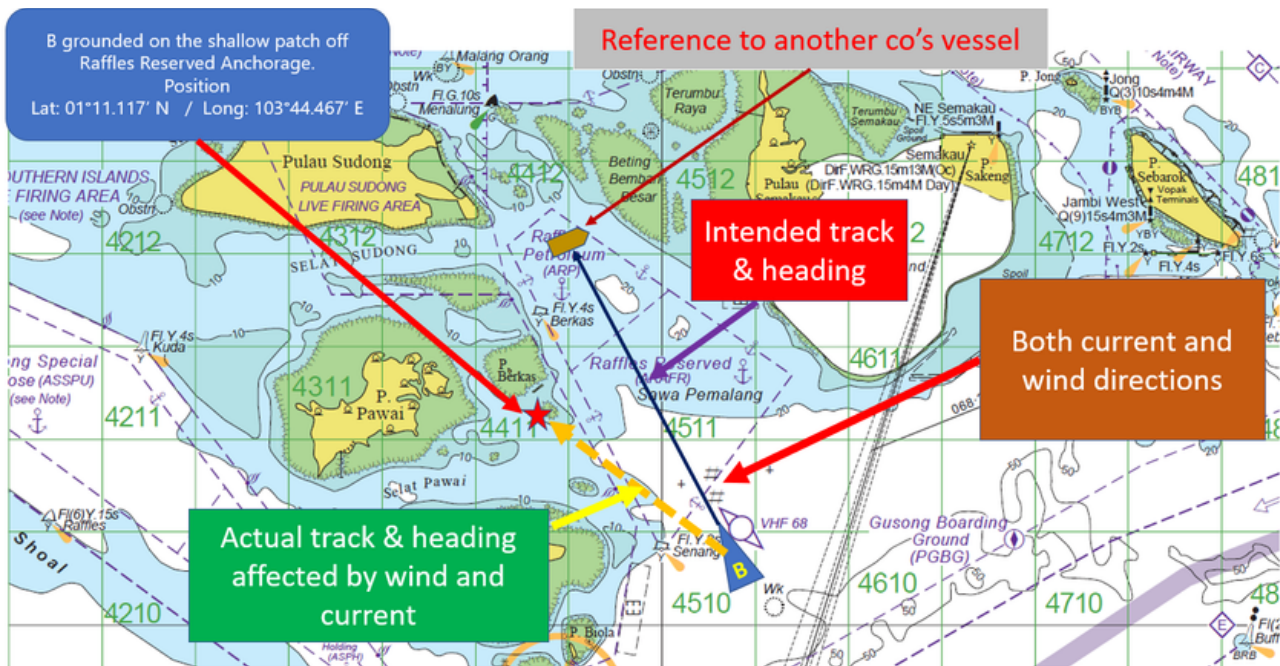
B casted off from a bunker receiving vessel in the vicinity of Senang buoy and headed toward Raffles Petroleum Anchorage (RPA). B's gyro compass was not working properly hence causing abnormal function of her radar simultaneously. Unable to use the radar, the master saw one of his company's vessels (CV) anchored at RPA and decided to visually navigate B by referring to CV. He took a magnetic bearing of CV and continued to steer B to head CV at the same magnetic bearing, around North Westerly. The master confirmed that he was aware of the prevailing current and wind conditions, i.e., both elements were pushing B to her port, i.e., current set at 247° (T) with 1.0 kts drift, increasing; with 20 kts wind from Northeast. B eventually grounded, 12 minutes after casting off from bunker receiving vessel. See Figure 1 below.

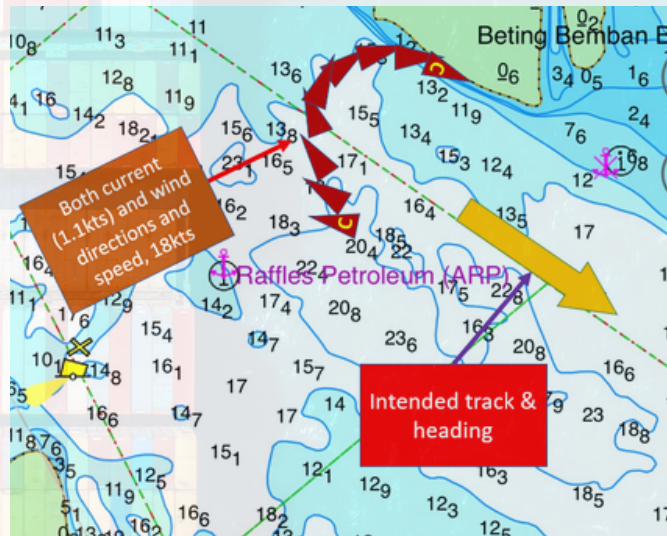
Both grounding incidents happened within the same vicinity. The weather conditions were similar at the material time. In both cases, masters had not appreciated the strong current and wind weather conditions. Instead of steering the vessels based on course made good, both had concentrated on their respective vessel’s heading. In case study 2(b), both current and wind were pushing his vessel from the port and the master turned his vessel to the starboard, which assisted her grounding (see Figure 3, above).

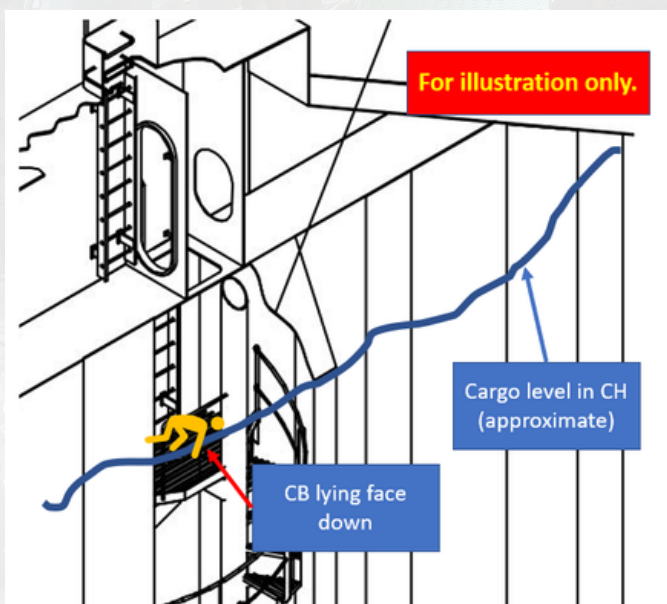
Subsequently, ship crew managed to bring CB on deck. Master sought assistance from shore to convey CB to shore medical facility. Meantime, second officer administered CPR on CB while waiting for shore medical transportation. When CB was conveyed to hospital, he was pronounced dead on arrival.
