## SINGAPOREAN NOTICES TO MARINERS

The monthly Notices to Mariners contain information required to keep charts and publications published by the Hydrographic Division, Maritime and Port Authority of Singapore up-to-date.

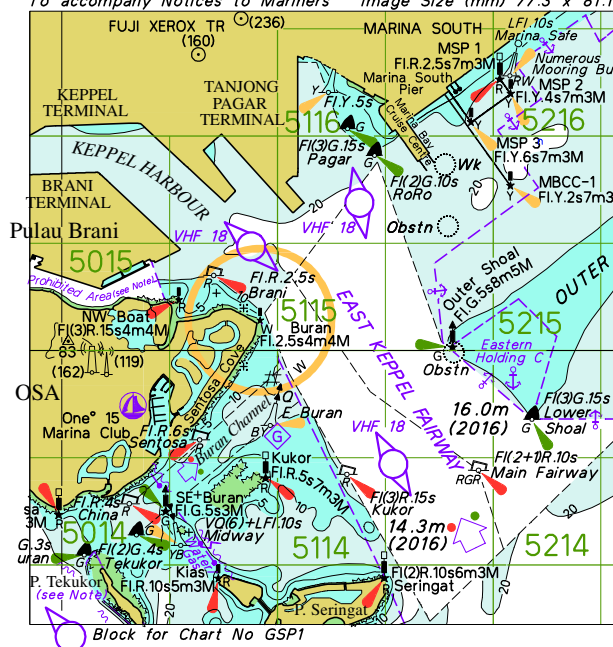
Block for Chart No SP1

<b>GSP1/SP1</b>	3 Ed 15/1/18	Last NM 27/2019 (Maritime and Port Authority of Singapore)	<b>NM 40/2019</b>
<b>Insert</b>	the accompanying block, centered on:		1°15'15"N 103°51'19"E
<b>201</b>	6 Ed 15/9/17	Last NM 29/2019 (Royal Malaysian Navy Notice no. 2/54/2019)	<b>NM 41/2019</b>
<b>Replace</b>

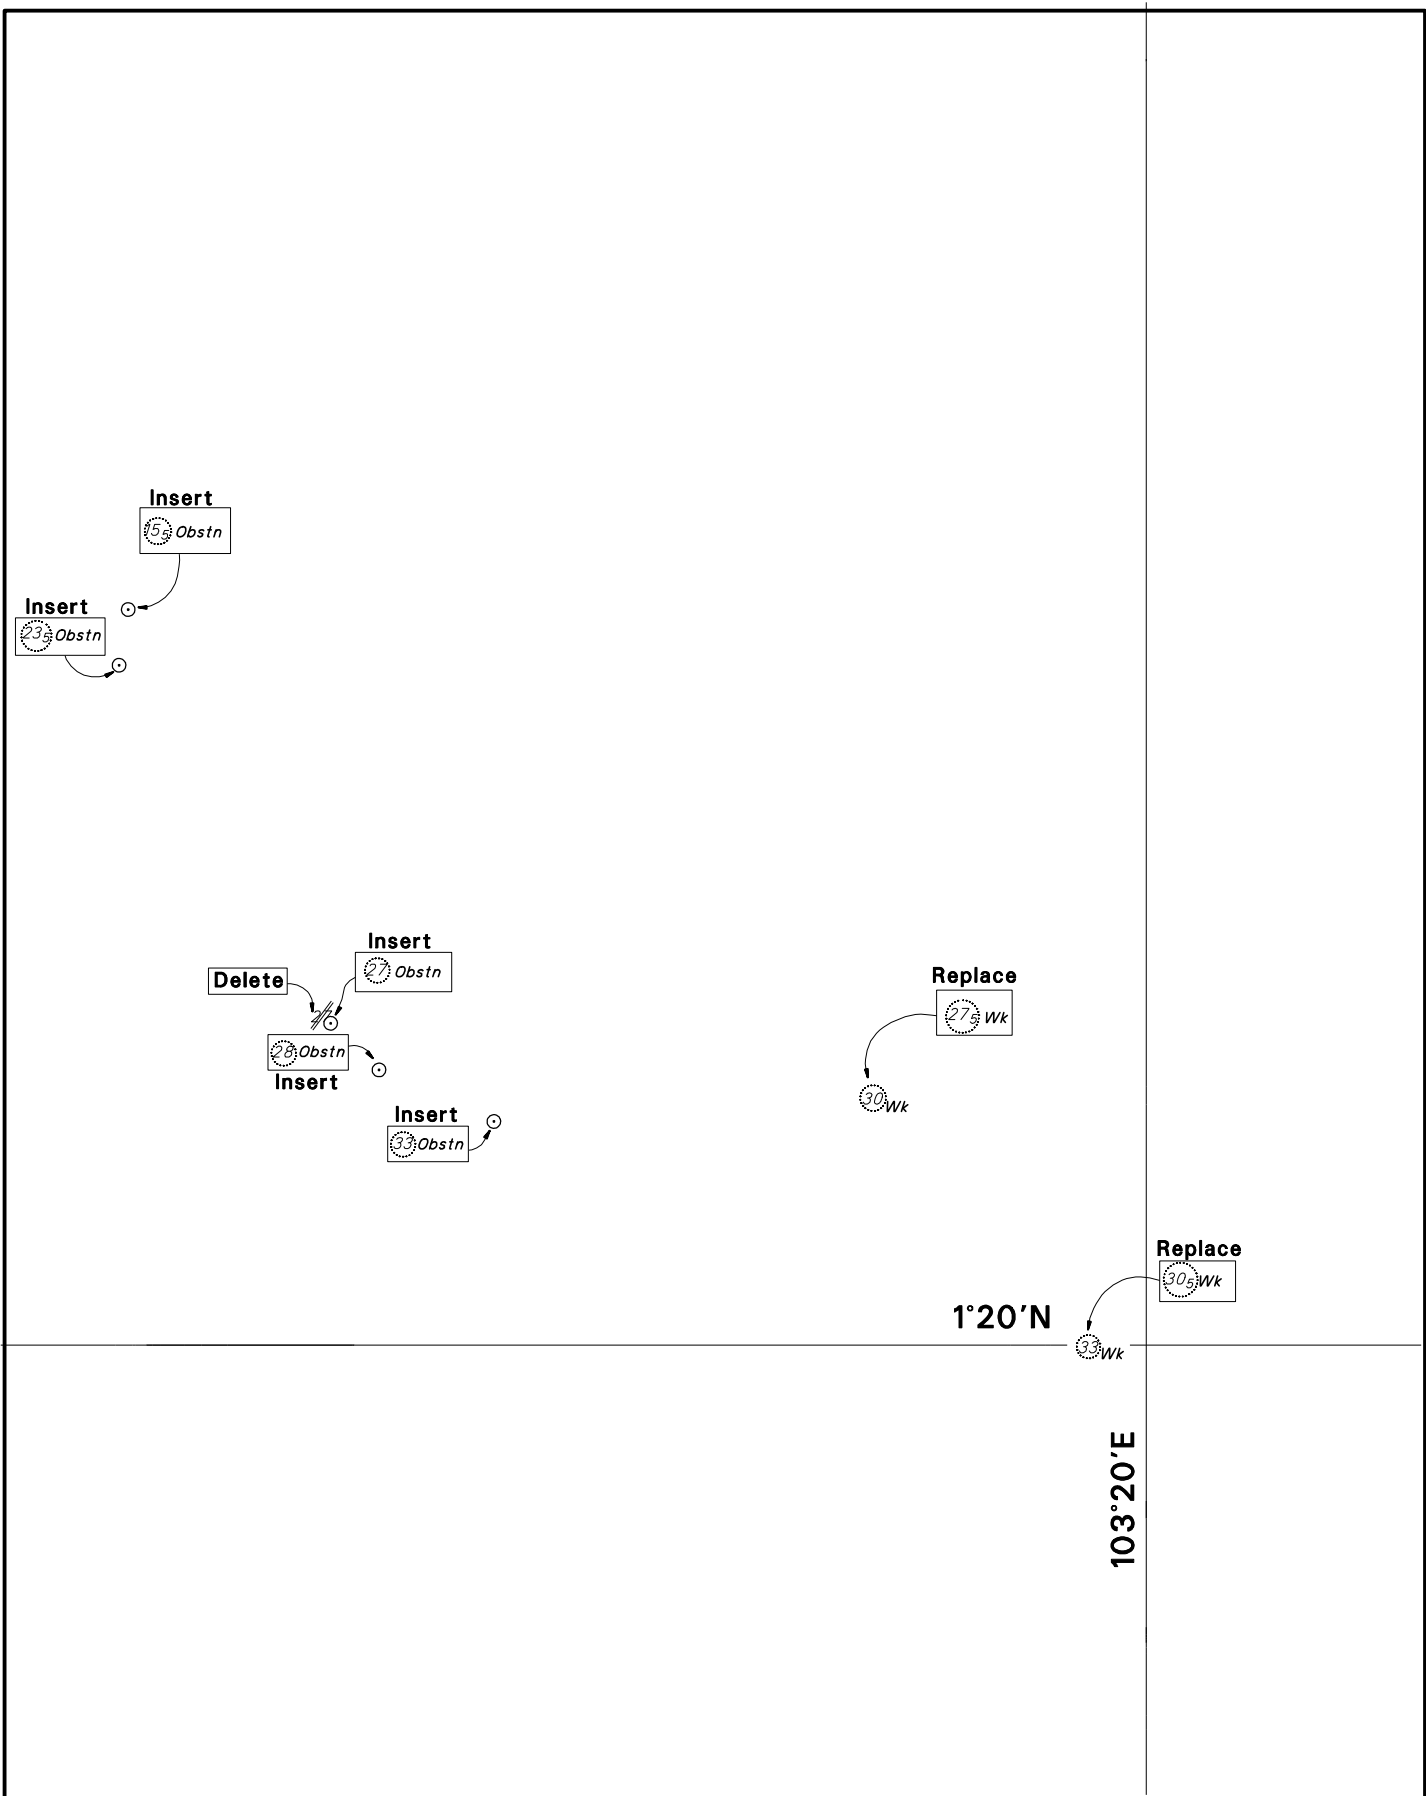
CORRECTION NO.	SNM EDN NO.	LAST CORR N NO.	CHART NO.	Location on Chart		
41 (sheet 1)	4/2019	29/2019	201			
						X

<i>Obstn</i>	1°23'21"N	103°10'69"E
<b>Delete</b>	depth, <sup>27</sup>	1°24'73"N	103°08'23"E

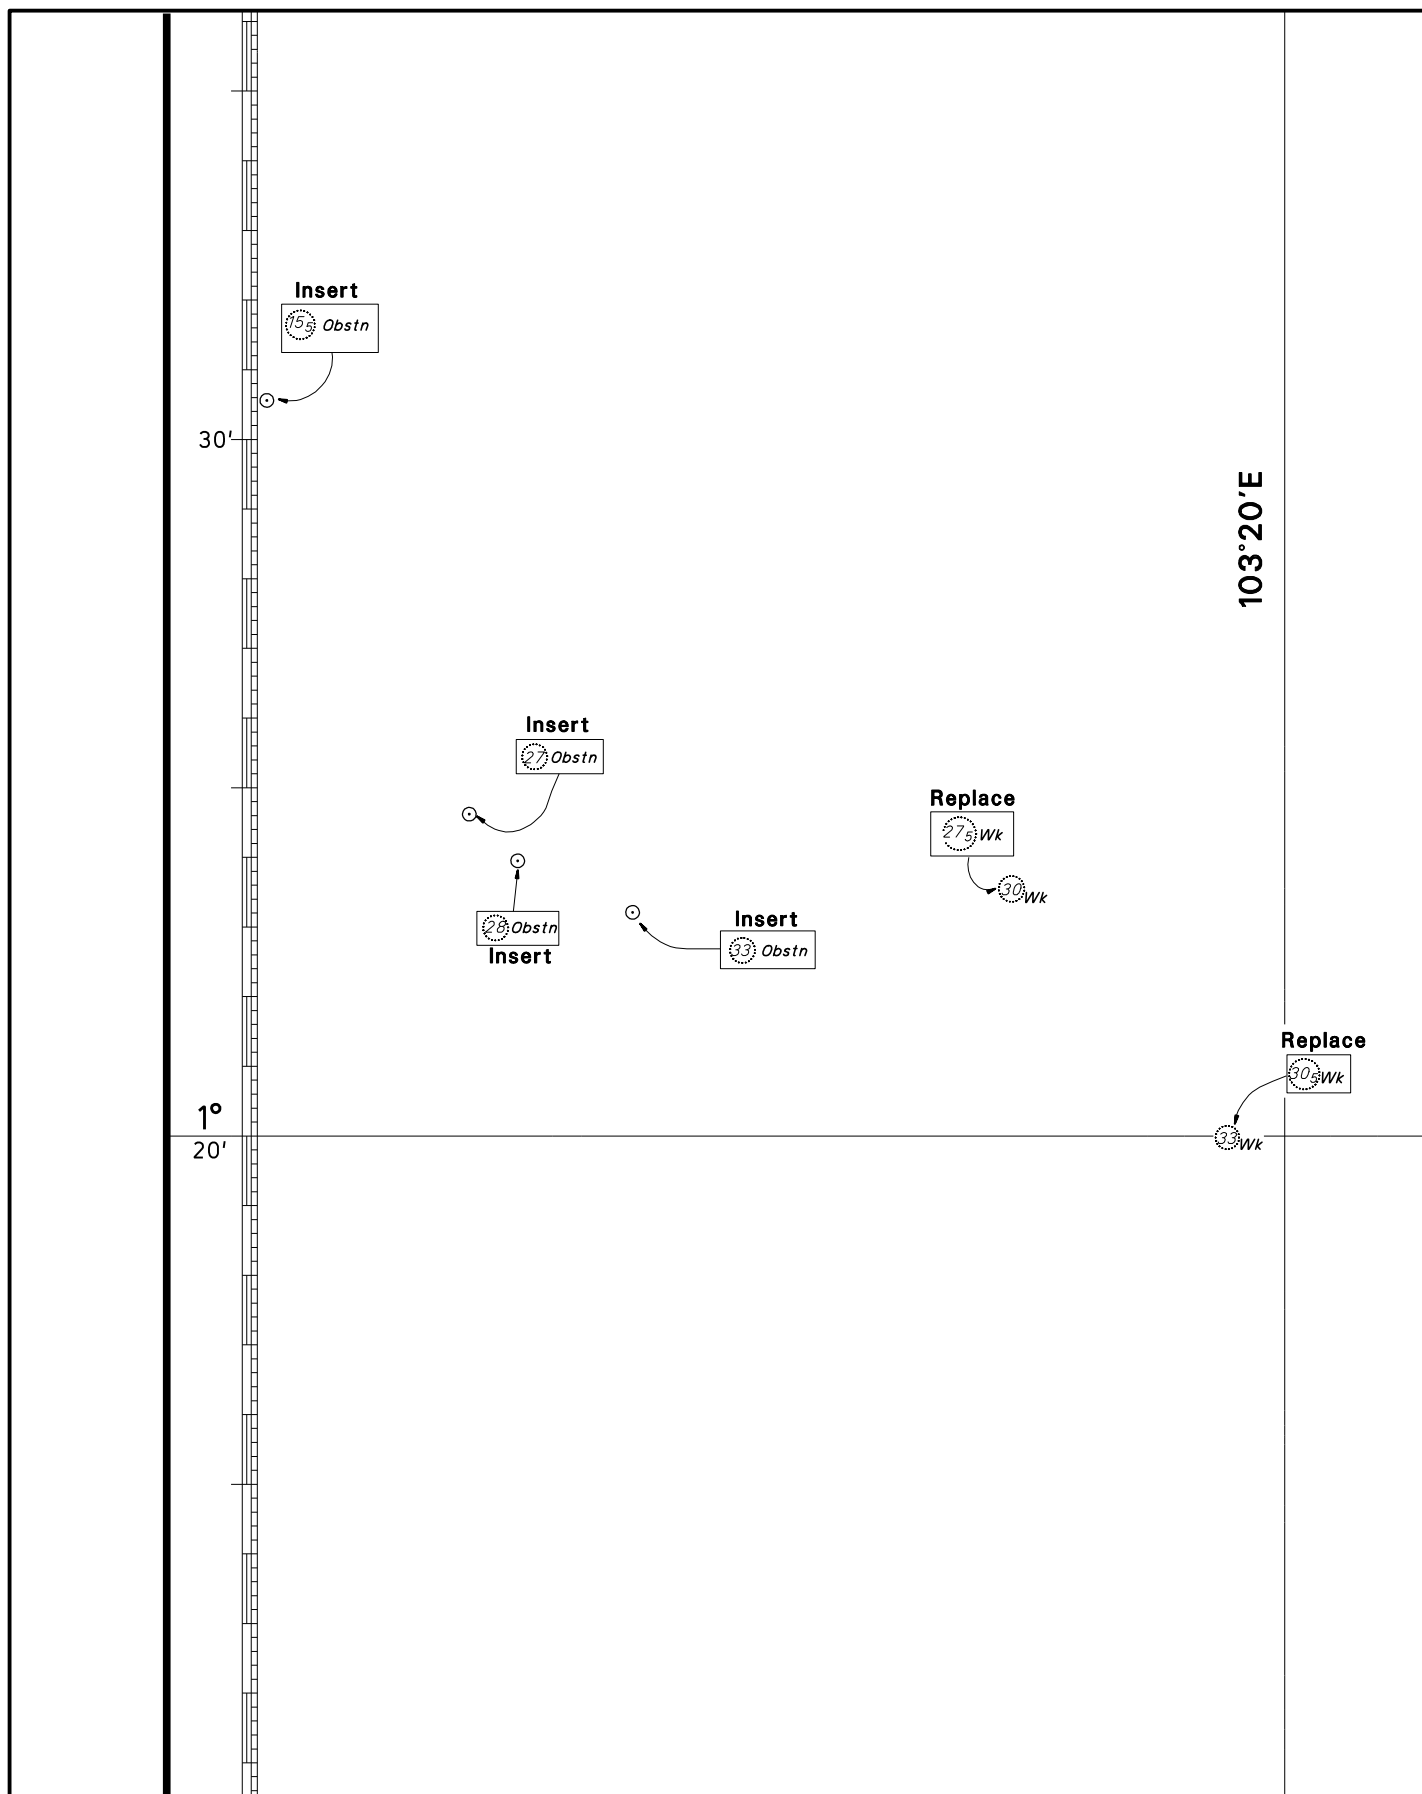
CORRECTION NO.	SNM EDN NO.	LAST CORR NO.	CHART NO.	Location on Chart		
41	4/2019	32/2019	202	X

<i>Obstn</i>	1°23·21'N	103°10·69'E
<hr/>			
<b>500</b>	8 Ed 15/9/17	Last NM 33/2019 (Royal Malaysian Navy Notice no. 2/54/2019)	<b>NM 41/2019</b>
<b>Replace</b>

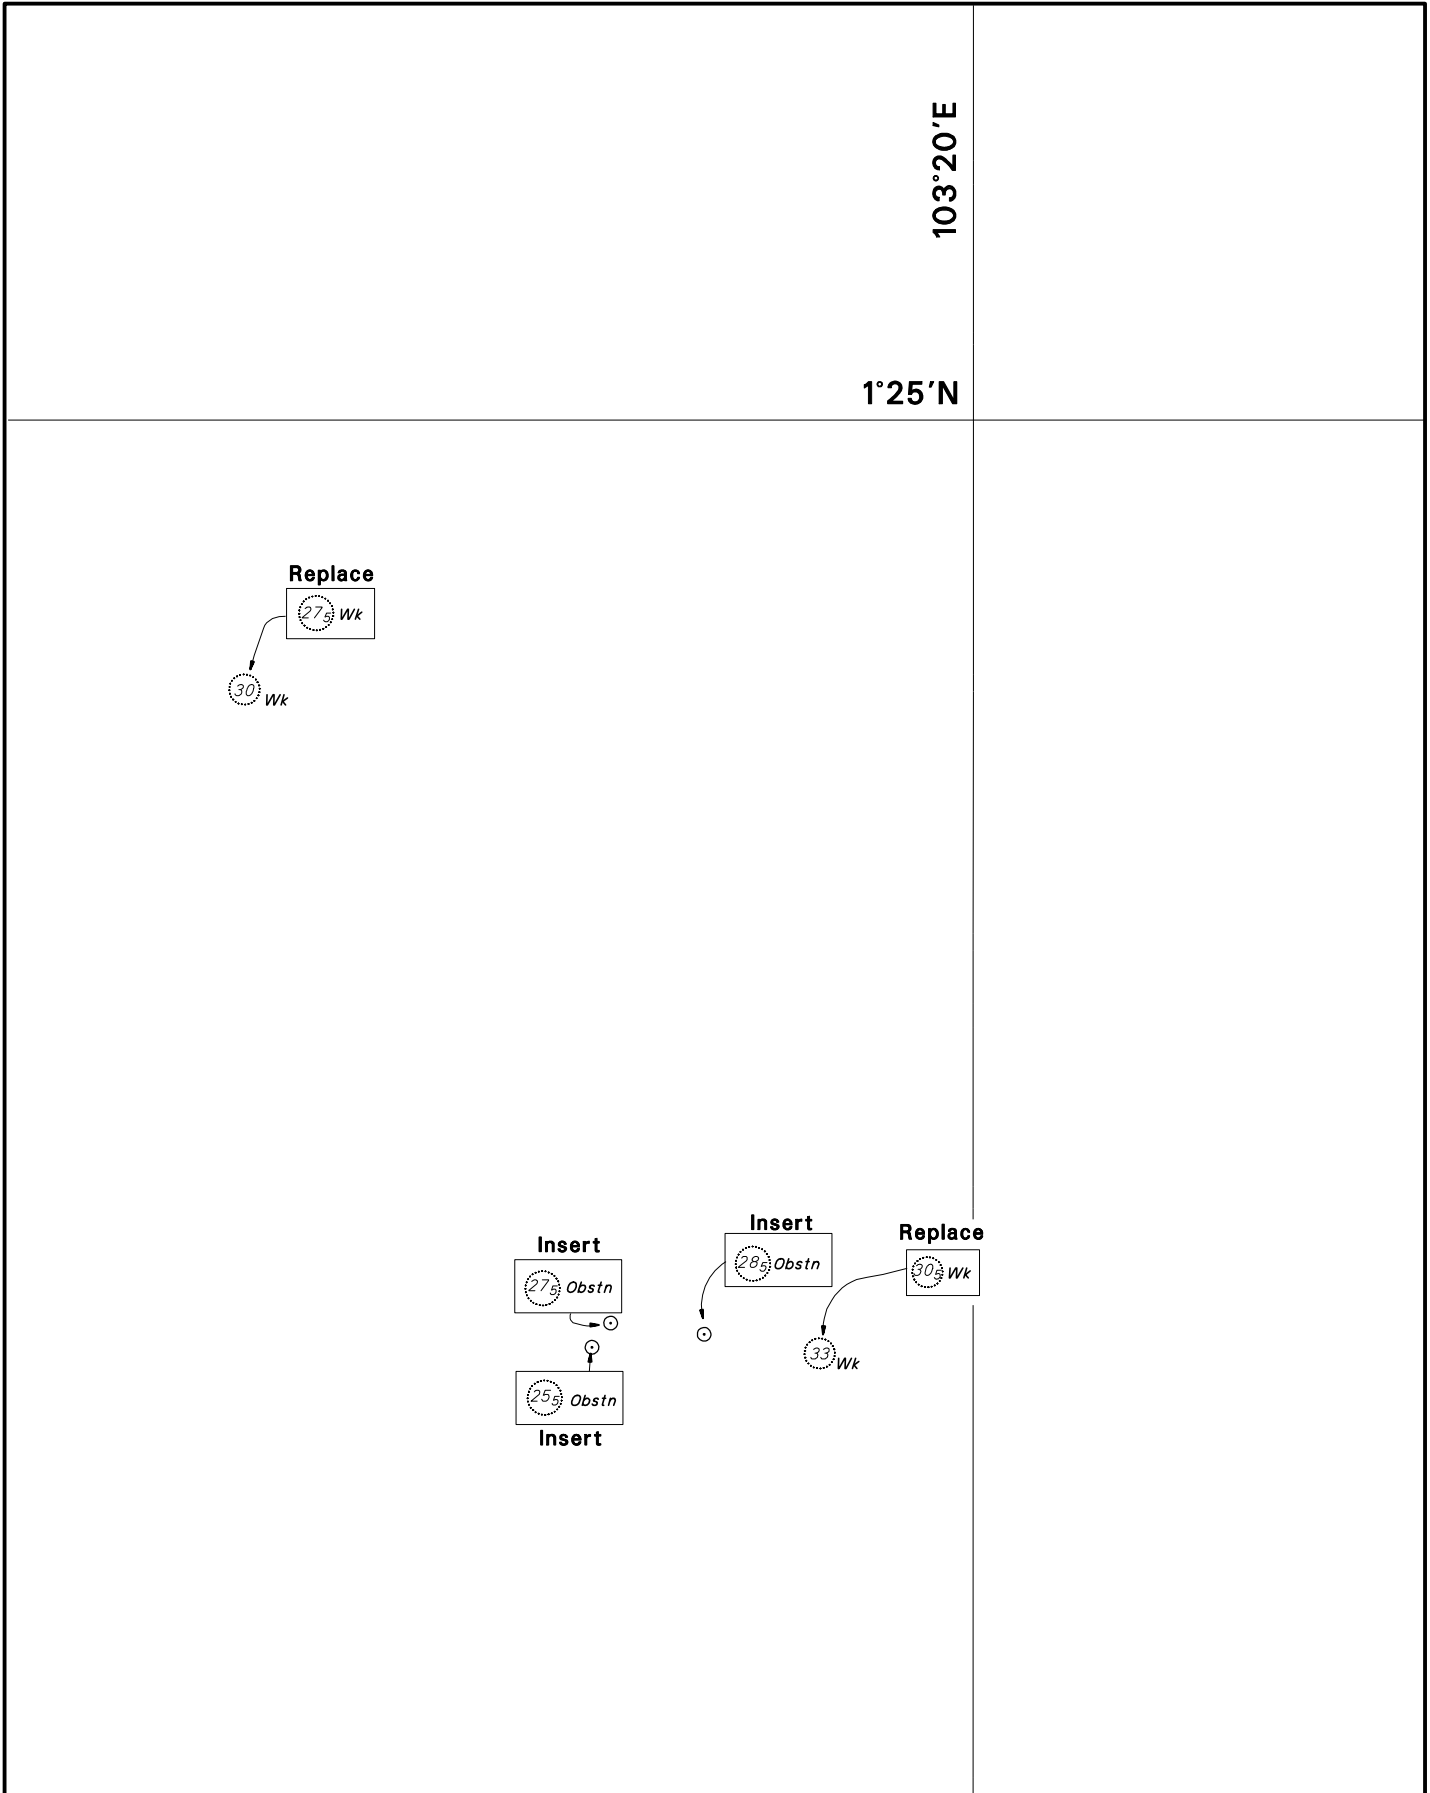
CORRECTION NO.	SNM EDN NO.	LAST CORR N O.	CHART NO.	Location on Chart		
				X		
41 (sheet 1)	4/2019	33/2019	500

<i>Obstn</i>	1°20·08'N	103°18·56'E
<hr/>			
<b>502</b>	7 Ed 1/9/15	Last NM 34/2019 (Maritime and Port Authority of Singapore)	<b>NM 43/2019</b>
<b>Insert</b>	depth, <i>24<sub>9</sub></i>	1°17·18'N	104°05·16'E
		(Maritime and Port Authority of Singapore)	<b>NM 44/2019</b>
<b>Delete</b>	depth, <i>24</i>	1°17·41'N	104°06·64'E
<b>Insert</b>	depth, <i>23<sub>2</sub></i>	1°17·39'N	104°06·65'E
	depth, <i>23<sub>9</sub></i>	1°17·53'N	104°06·79'E
