## SINGAPOREAN NOTICES TO MARINERS

**SECTION I**  
**INDEX OF CHARTS AND PUBLICATIONS AFFECTED**

**SECTION II  
SINGAPORE NOTICES**

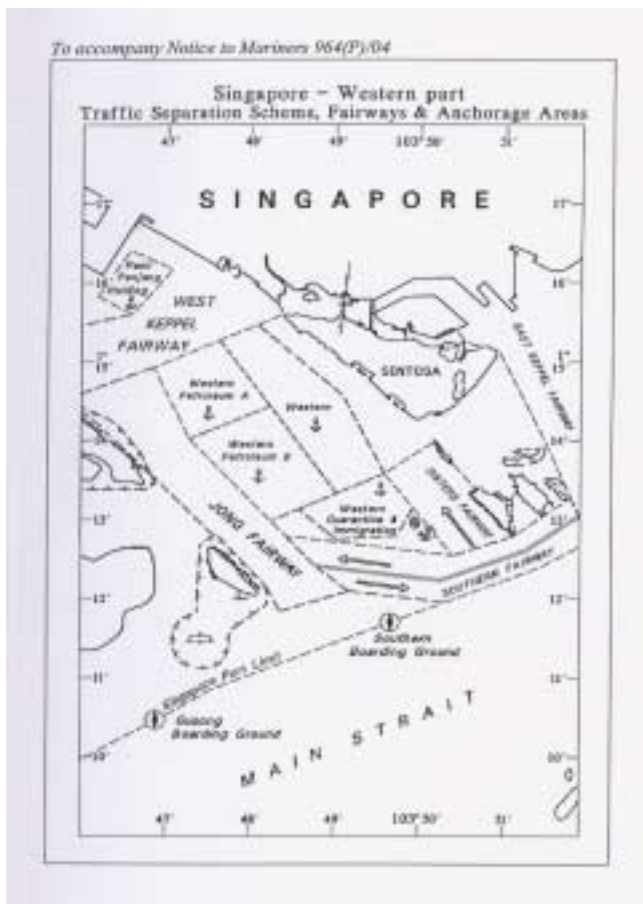
**Chart affected - 4041**

**964(P)/04 SINGAPORE – Western part – Traffic Separation Scheme, Fairways, Anchorage Areas.**

1. Mariners are advised that the following changes had been delayed but came into effect on 10 February 2004.
  - a. Realignment of the Traffic Separation Scheme in Southern Fairway.
  - b. Realignment of the West Keppel and Jong Fairways.
  - c. Revised limits of Western Petroleum A and B anchorages.
2. The accompanying diagram shows these changes.
3. These changes have already been included in the latest editions of Charts 4035, 4036 and 4040. They will be included in a New Edition of Chart 4041 in due course.
