SINGAPOREAN NOTICES TO MARINERS

GSP1/SP1 5 Ed 15/01/2021 Last NM 70/2021 (Maritime and Port Authority of Singapore) ***NM 74/2021**

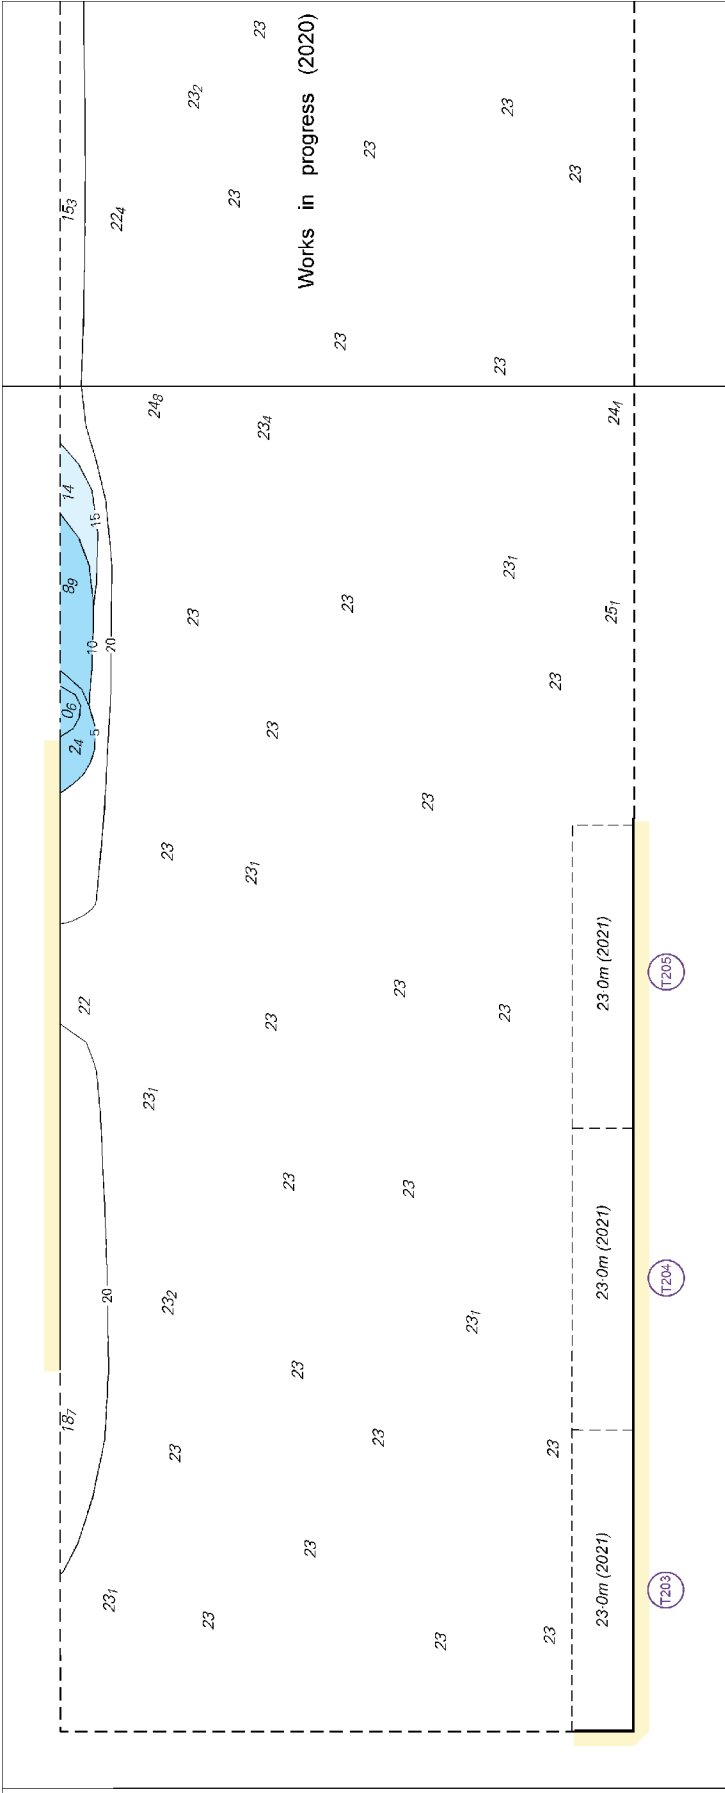
Block for Chart No 4030

Insert	the accompanying block, centred on:	1°15·4'N	103°37·6'E
---------------	-------------------------------------	----------	------------

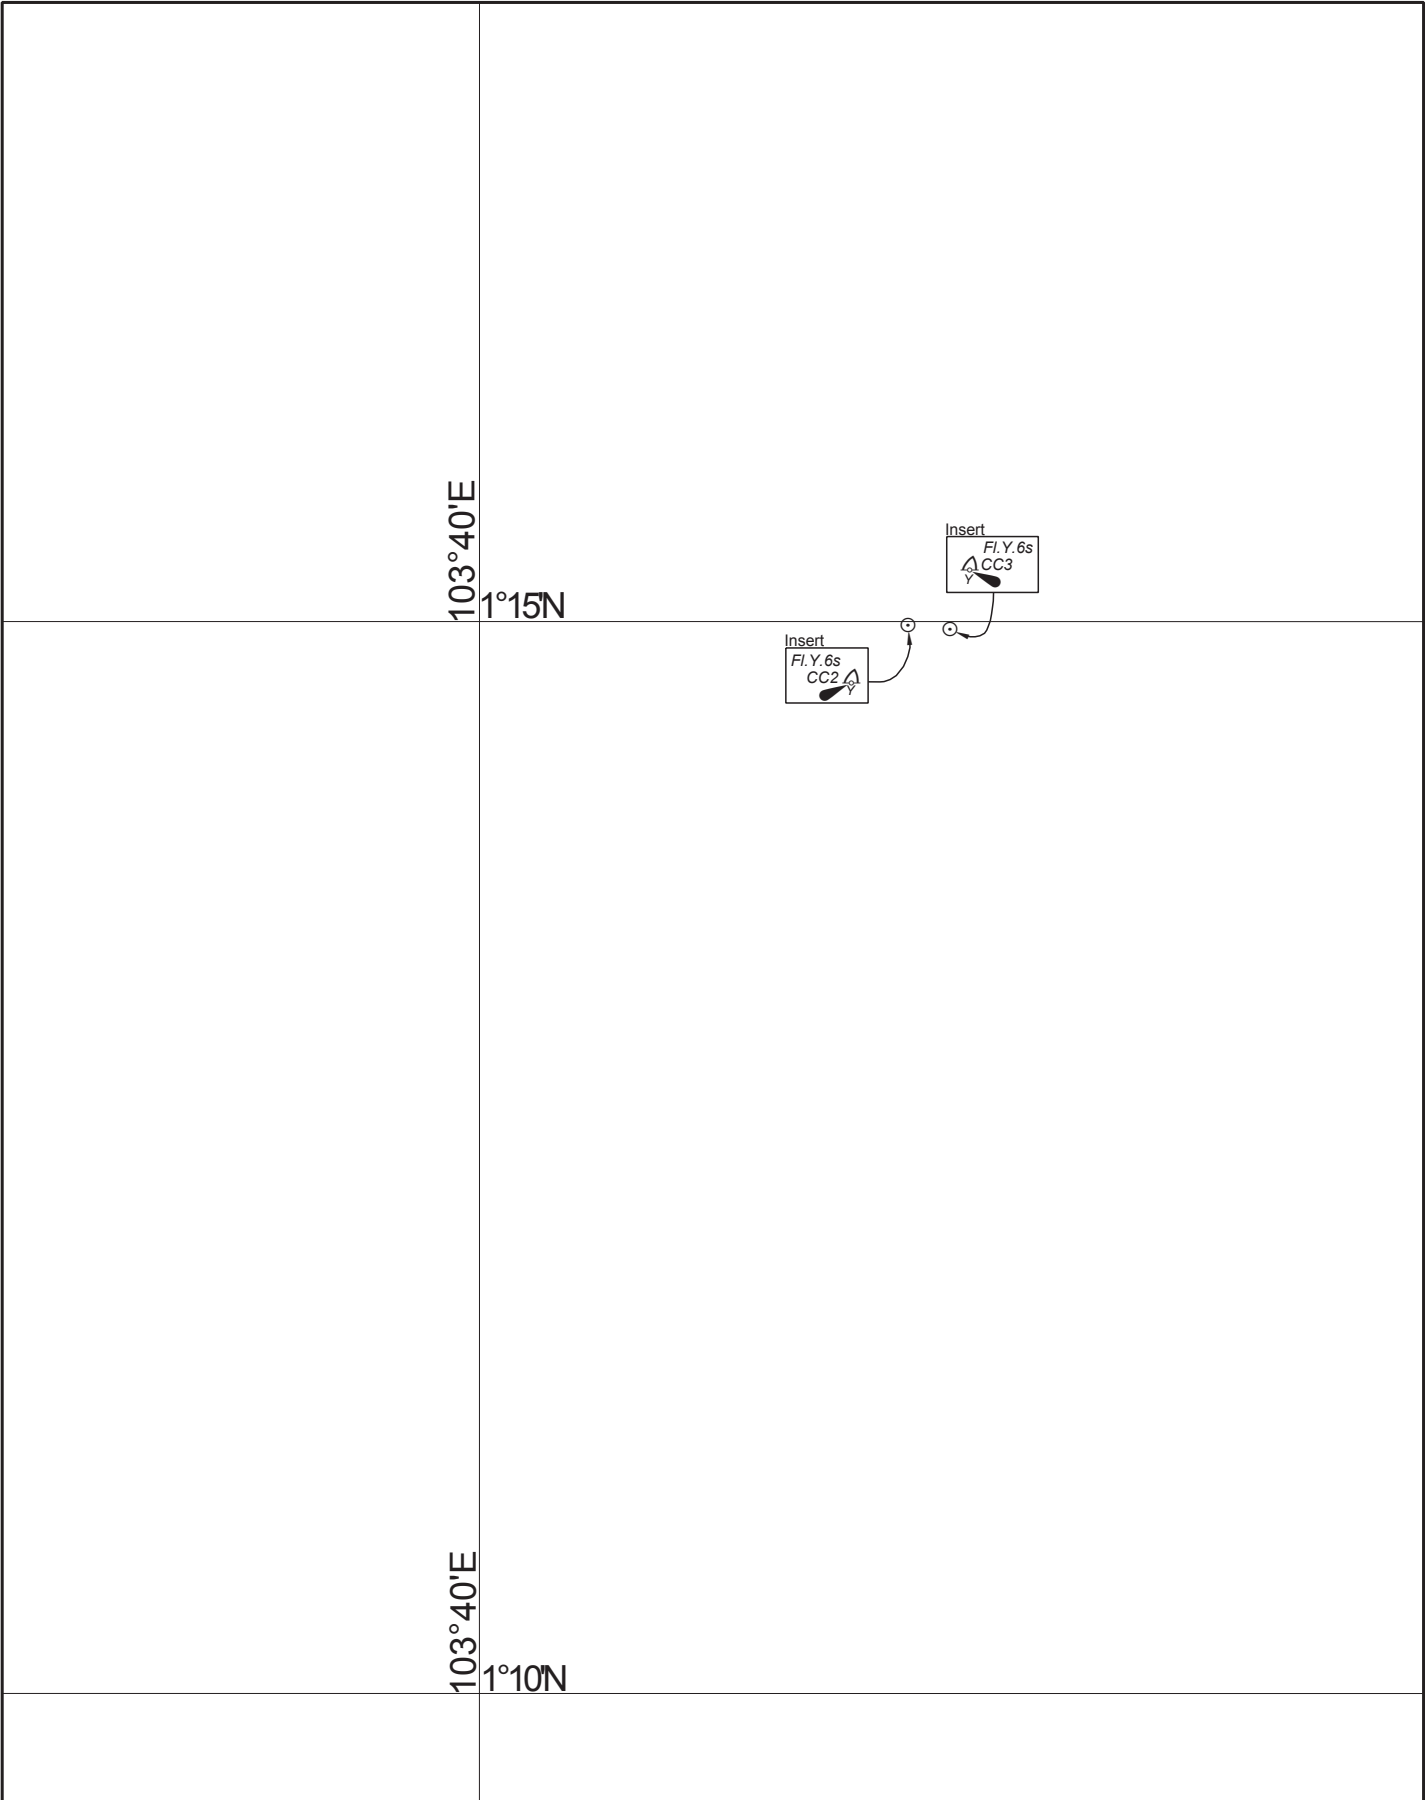
CORRECTION NO.	SNM EDN NO.	LAST CORR N NO.	CHART NO.	Location on Chart		
				X		
74	08/2021	70	GSP1/SP1

*Fl.Y.6s, CC2* 1°14·98'N 103°41·99'E

*Fl.Y.6s, CC3* 1°14·97'N 103°41·18'E

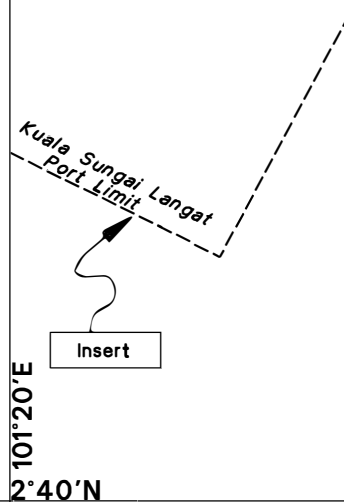
CORRECTION NO.	SNM EDN NO.	LAST CORR N NO.	CHART NO.	Location on Chart		
				X		
75	08/2021	56	200

200 4 Ed 1/09/2015 Last NM 56/2021 (Royal Malaysian Navy Notice no. 05/109/2021) **NM 75/2021**

Insert maritime limit, pecked line, joining: 2°45·00'N 101°20·00'E

legend, *Kuala Sungai Langat Port Limit*, centred on: 2°44·59'N 101°21·35'E
