SINGAPOREAN NOTICES TO MARINERS

GSP1/SP1 3 Ed 15/1/18 Last NM 104/2019 (Malaysia Marine Department Notice No. 184/2019) **NM 2/2020**

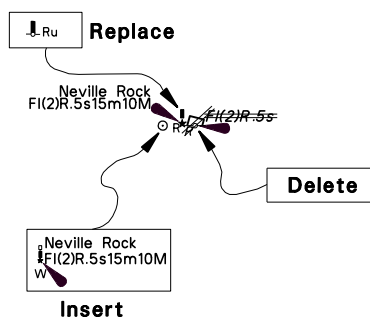
CORRECTION NO.	SNM EDN NO.	LAST CORR NO.	CHART NO.	Location on Chart		
						X
2/2020	1/2020	104/2019	GSP1/SP1

Neville Rock <i>FI(2)R.5s15m10M</i> , with

Neville Rock <i>FI(2)R.5s15m10M</i>	1°26·66'N	104°02·64'E
