SINGAPOREAN NOTICES TO MARINERS

The monthly Notices to Mariners contain information required to keep charts and publications published by the Hydrographic Division, Maritime and Port Authority of Singapore up-to-date.

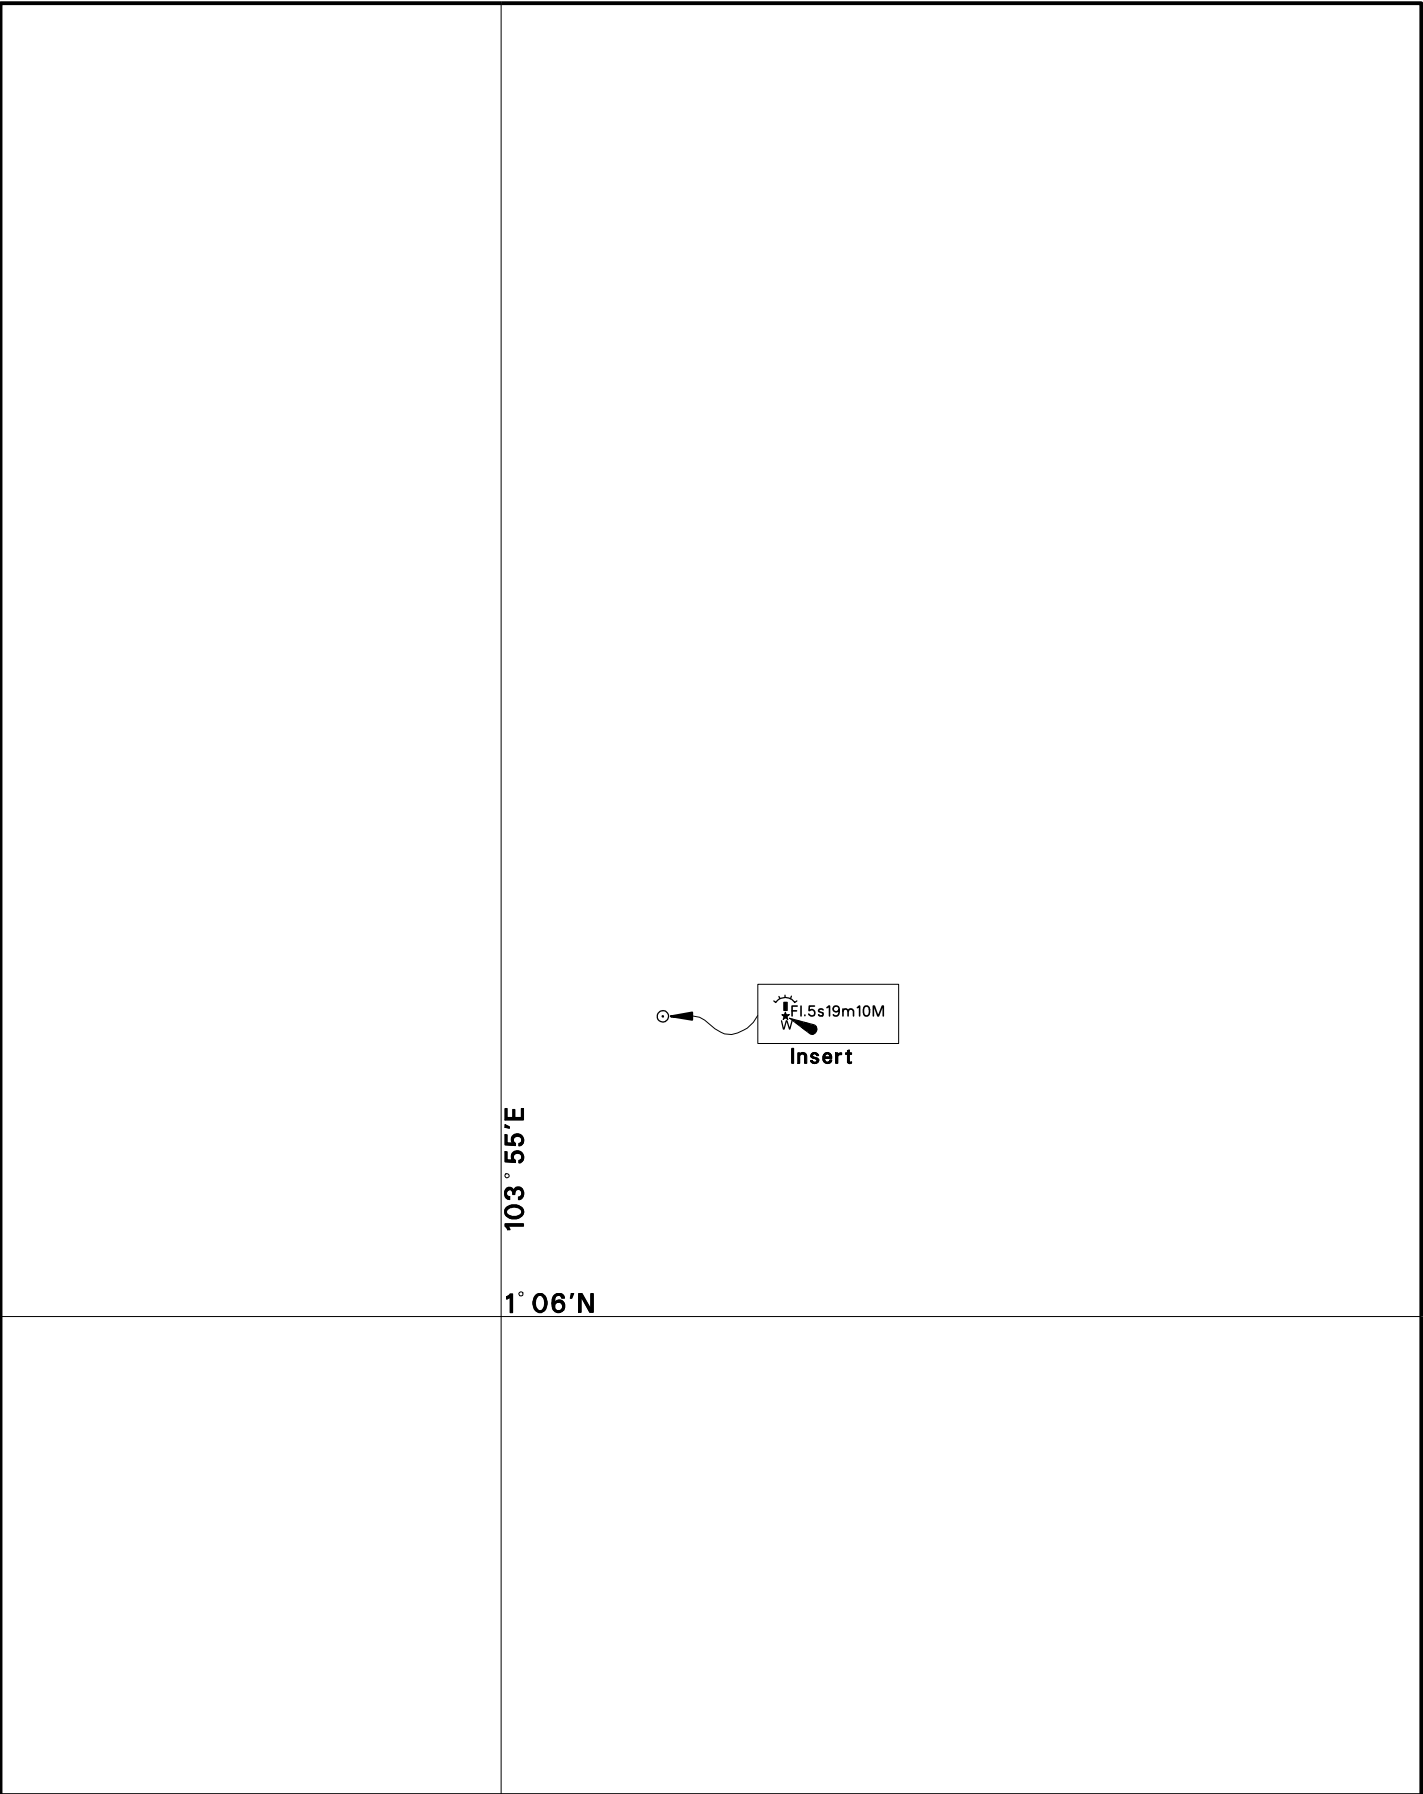
CORRECTION NO.	SNM EDN NO.	LAST CORR N NO.	CHART NO.	Location on Chart		
104	11/2019	96/2019	GSP1/SP1	X

NM 104/2019

Fl.5s19m10M	1°07·40'N	103°55·75'E
---------------	---	-----------	-------------

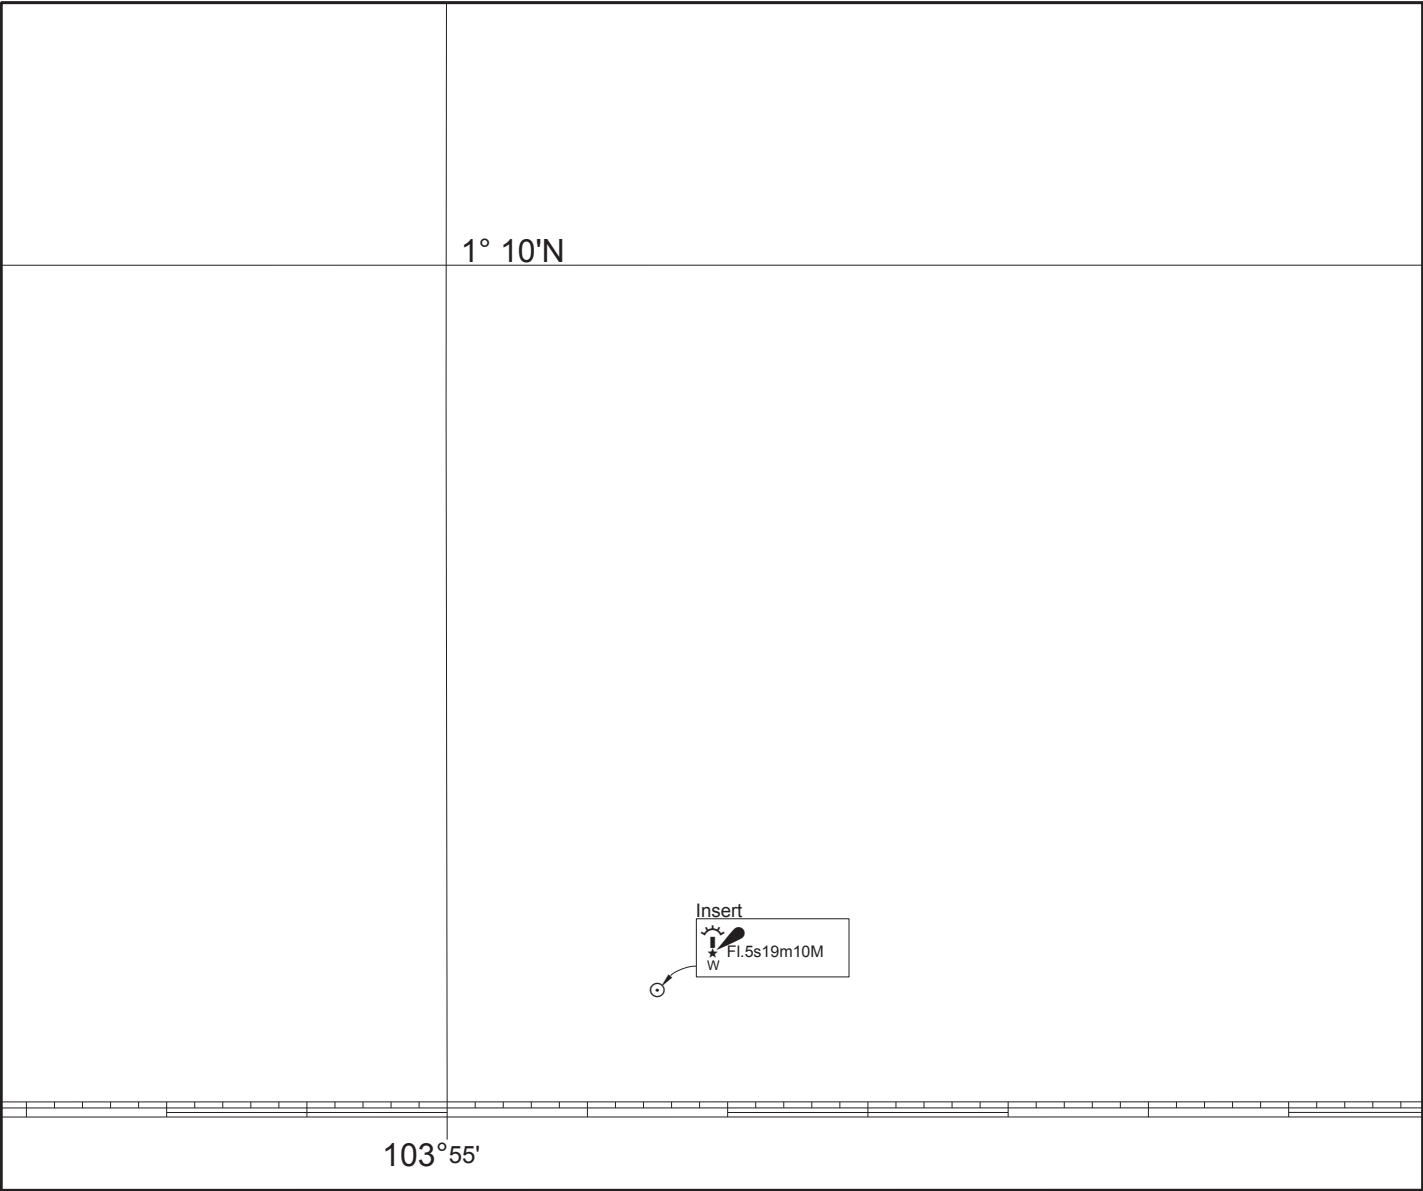
CORRECTION NO.	SNM EDN NO.	LAST CORR N NO.	CHART NO.	Location on Chart		
104	11/2019	-	502	X

502	8 Ed 12/9/19	(Indonesia notice no. 41/543/2019)	NM 104/2019
------------	--------------	------------------------------------	--------------------

Fl.5s19m10M	1°07·40'N	103°55·75'E
---------------	---	-----------	-------------
