SINGAPOREAN NOTICES TO MARINERS

***(NM73/2002) DUAL BADGED CHARTS TO BE PUBLISHED ON 26TH SEPTEMBER 2002.**

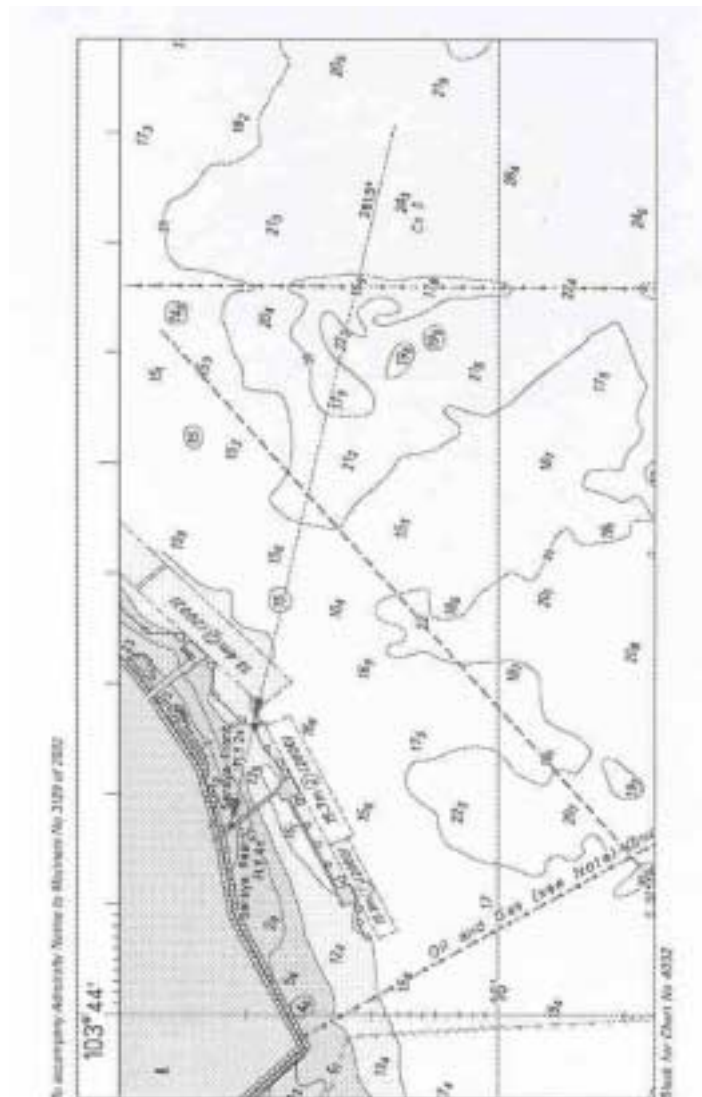
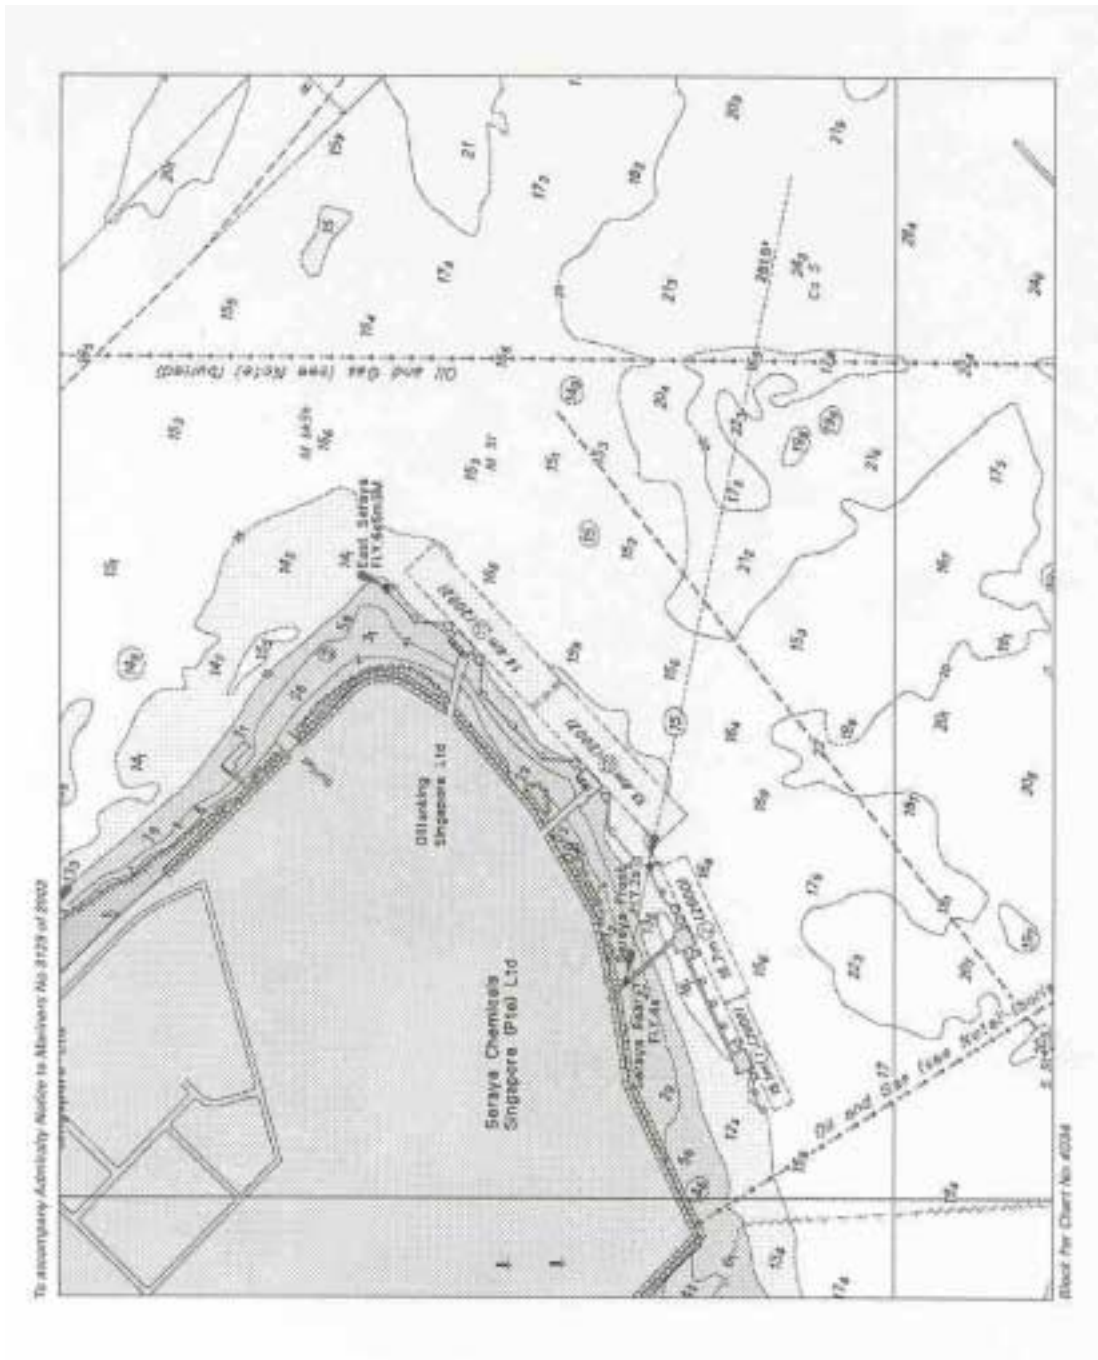
3129*/02 SINGAPORE STRAIT – Singapore – Jurong Island, East Coast – Jetties: Depths: Works: Light

Insert	the accompanying block, showing amendments to jetties, and depths and works area, centred on:	(a) 1°16'.103N.,	103°44'.405E.
	the accompanying block, showing amendments to jetties, and depths and works area, centred on:	(a) 1°16'.267N.,	103°44'.405E.

NOTE : This block correction is for illustration only. The actual block correction can be obtained from Admiralty Notices to Mariners Weekly Edition 30.
