SINGAPOREAN NOTICES TO MARINERS

503 5 Ed 15/08/14 Last NM 107/2025 (Maritime and Port Authority of Singapore) ***NM 31/2026**

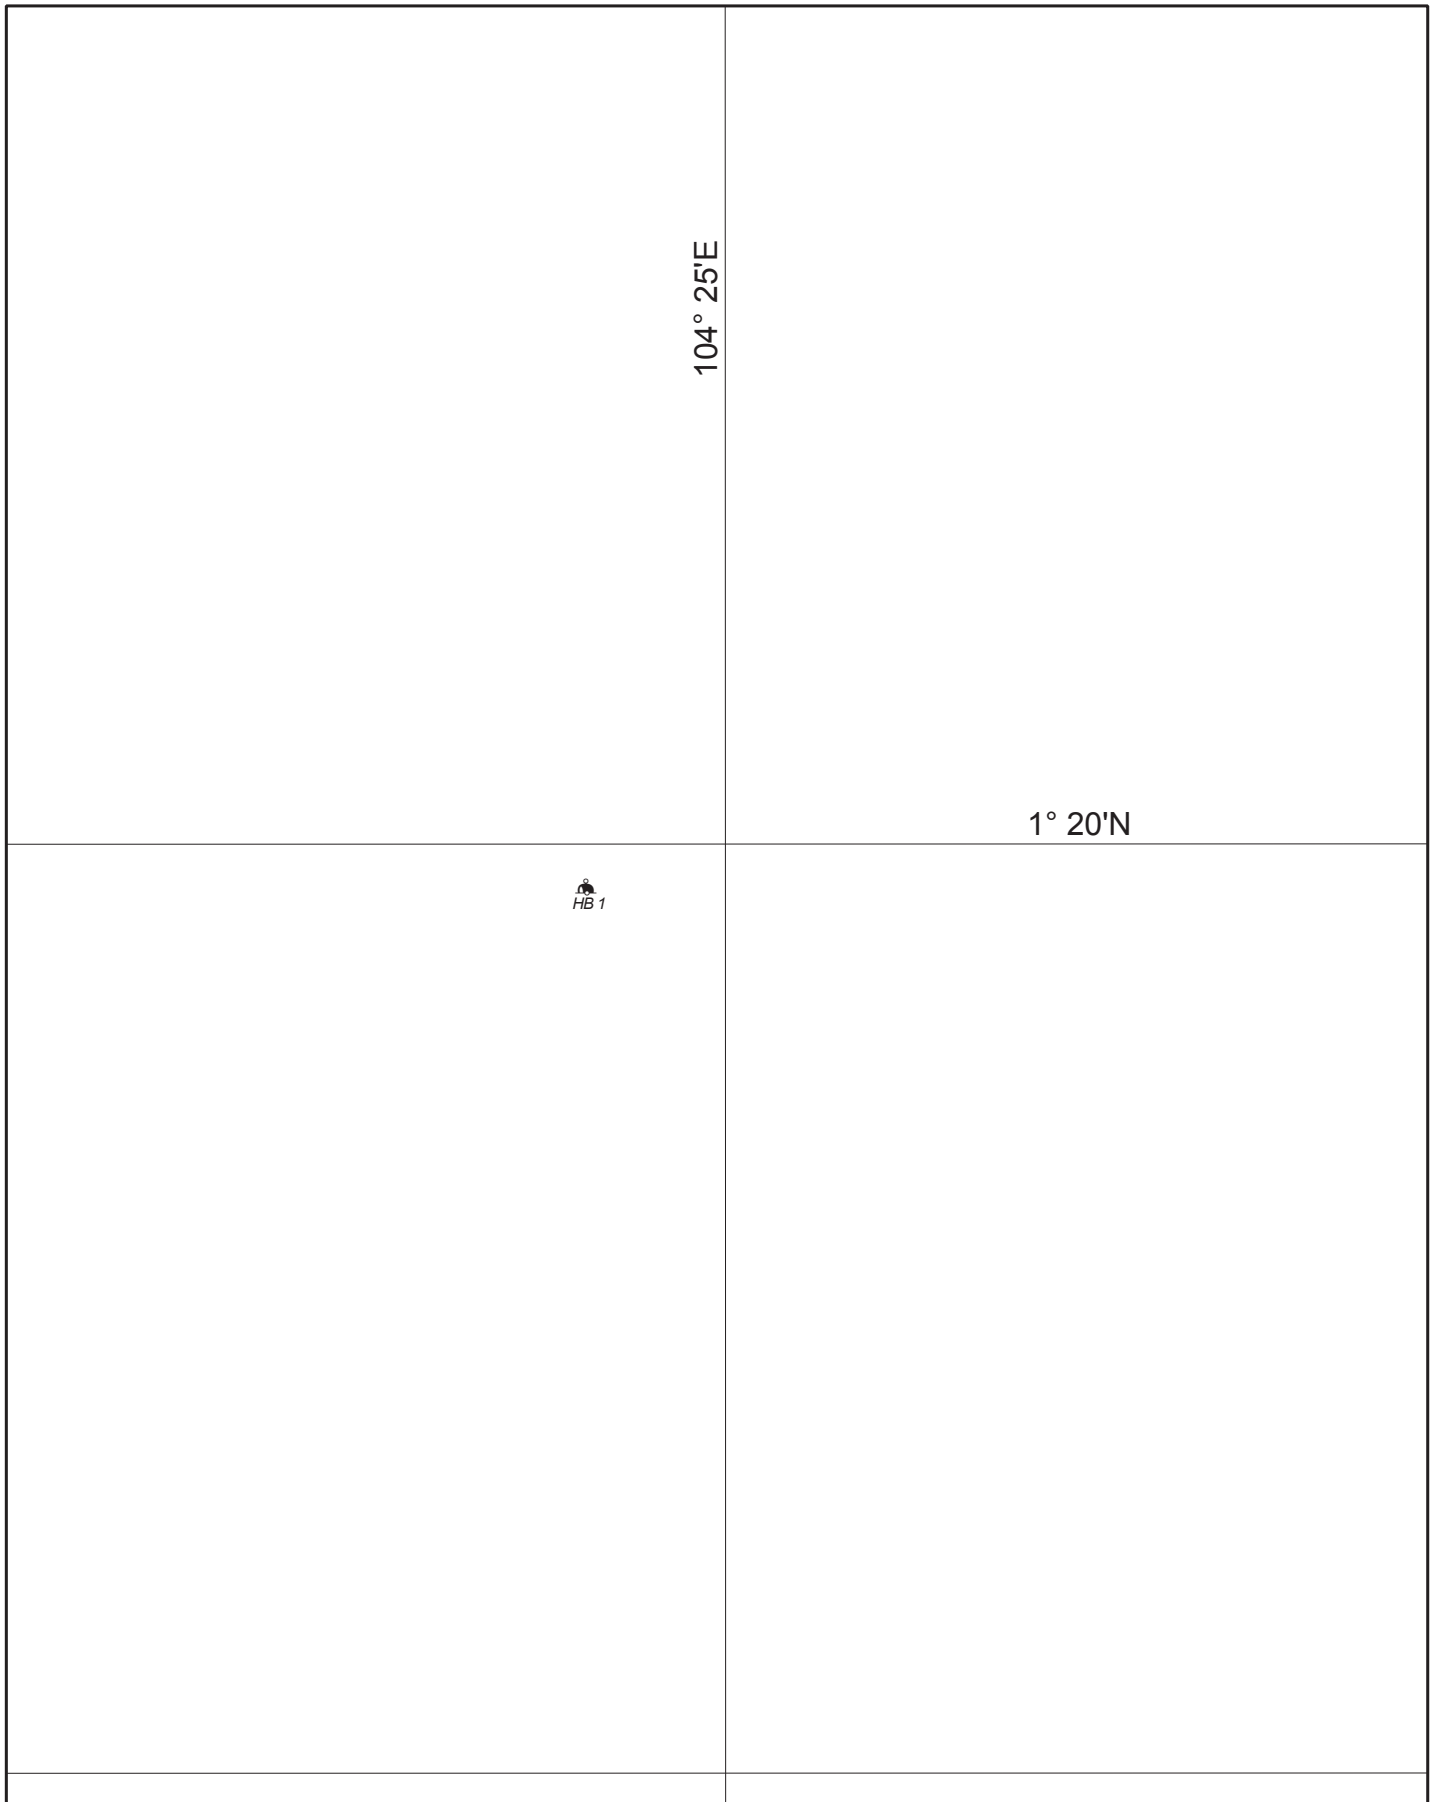
CORRECTION NO.	SNM EDN NO.	LAST CORR N NO.	CHART NO.	Location on Chart		
31	05	107/2025	503		X

Insert

*HB 1* 1°19.74'N 104°24.26'E
