SRS

E-BULLETIN

December 2024

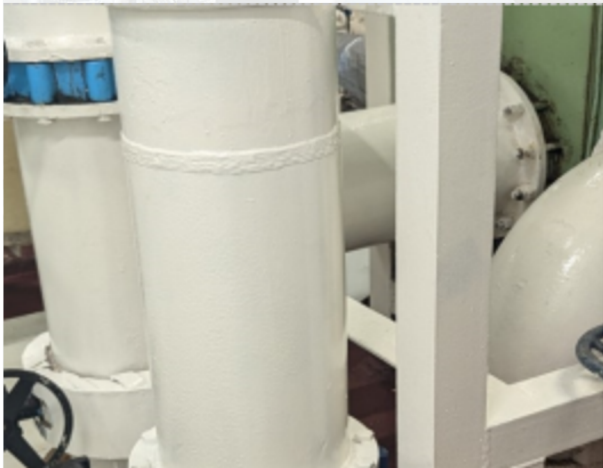
On 2 separate occasions in the engine room, the
(i) drained content from LT cooler piping arrangement (“1st Occurrence”) and
(ii) aft bilge (“2nd Occurrence”) were transferred to the Cargo Hold Bilge Holding Tank (“CHBHT”) instead of the engine room bilge holding tank.

(i) LT Cooler Piping Arrangement

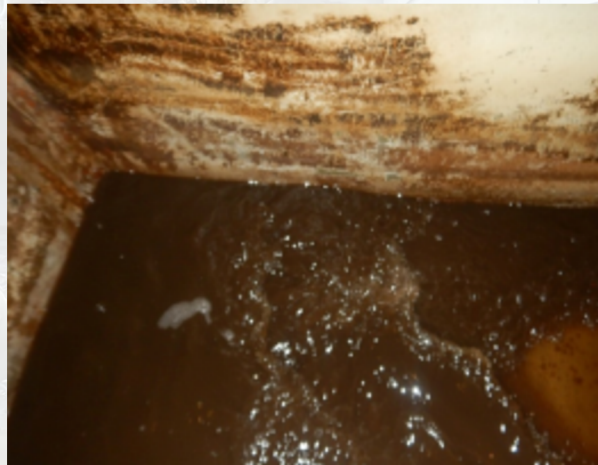
(ii) Aft Bilge

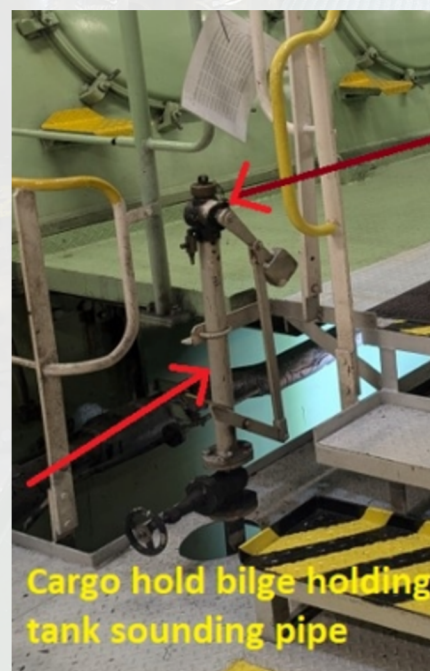
The above transfers for both occasions were carried out using portable pump and discharged through the CHBHT's sounding pipe. See screengrab on the right.

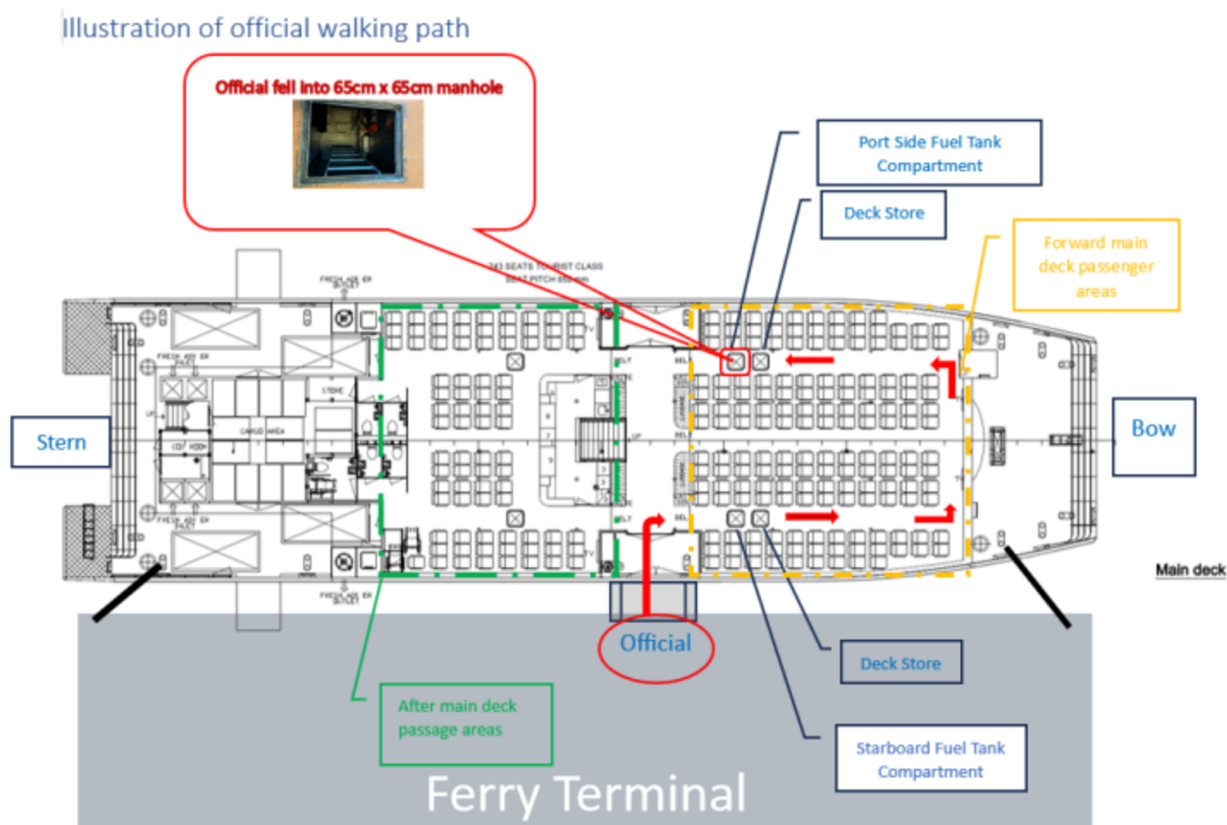
When a regional ferry arrived at a ferry terminal in Singapore, a ship's crew opened a manhole cover of fuel oil sounding compartment along the passageway of the passenger main deck compartment and proceeded down to take sounding. Subsequently, a Shore Official (SO), who was carrying out routine security check, accidentally fell into the open manhole and suffered a minor injury. See Figure 1 below.

However, the red cordon / warning signage on the starboard side was removed by the engineer after completing fuel oil sounding on the starboard side. He then proceeded to carry out fuel oil sounding at the port side, on the assumption that no personnel would enter the forward passenger compartment. Eventually, he opened the manhole cover at port side fuel oil sounding compartment and proceeded down without setting up any cordon / signages, manhole grating covers or requesting another crew to standby nearby the manhole.

Based on the ferry's CCTV video footage playback, the SO entered the starboard passenger way to carry out a routine security check. The SO fell into the open manhole fuel oil compartment while walking along port side passageway and suffered a minor injury.

It was assessed that the ferry's engineer had acted unsafely, having failed to put up a red cordon / warning sign, grating plate or safety barrier while leaving the open manhole unguarded. This implied that the engineer's safety risk perception was low. This plays a crucial role in decision-making regarding environmental and occupational risk management.

Additionally, there were no adopted procedures and/or work instructions with risk assessments to mitigate or eliminate the associated risks relating to daily fuel oil sounding

Lastly, the information of the open manhole cover was not made known to non-crew member, in this case, the SO, when boarding the ferry, and the SO was also unescorted by the ferry's crew, not in accordance with the ship security plan.

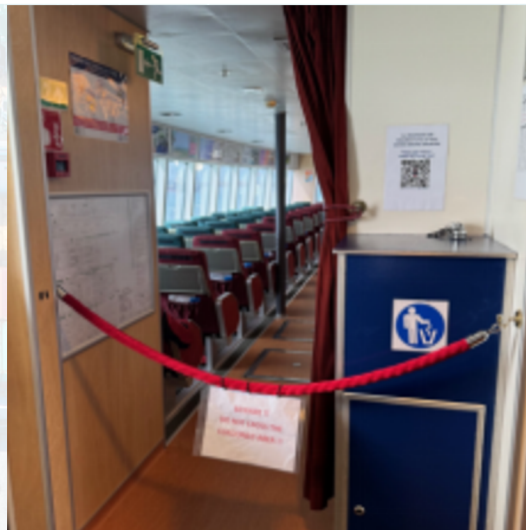
Port passageway with red cordon / warning signage

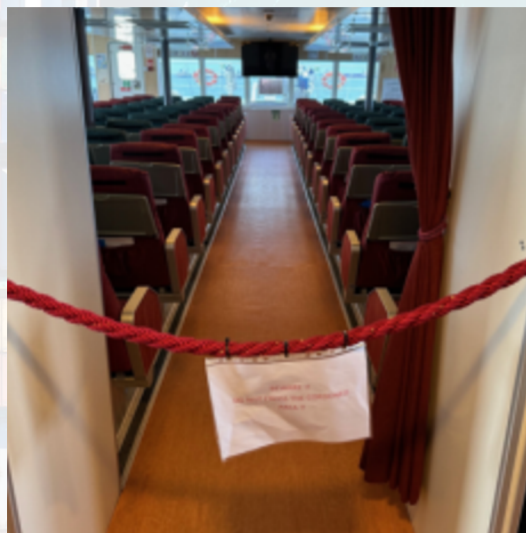
Centre passageway with red cordon / warning signage

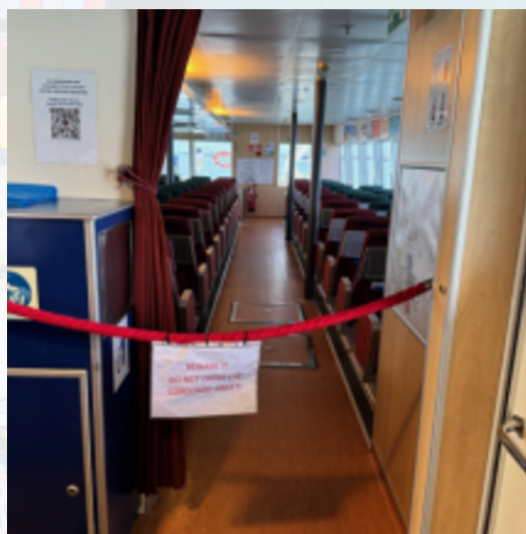
Starboard passage way with red cordon / warning signage

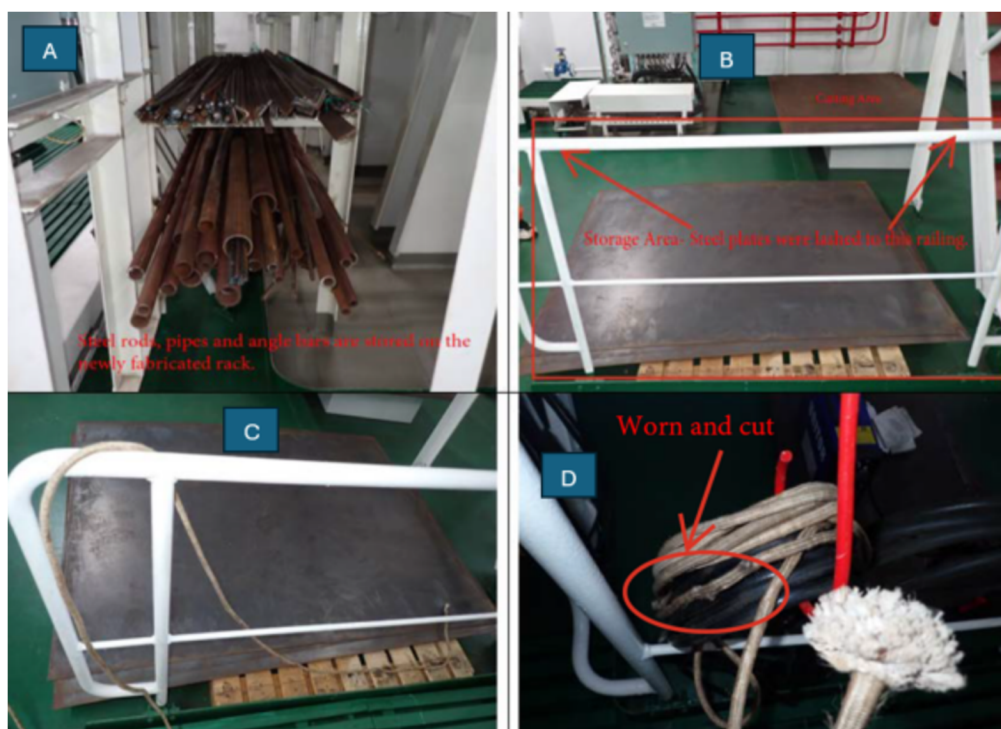
Figure 1

A vessel was on her maiden voyage from building yard. Many repair materials were supplied on board which were intended for use by the crew on board to fabricate additional storage boxes and tools. These materials were stored by ship's crew in the steering gear room. Steel rod, pipe and angle bars were stored on the newly fabricated storage rack (see A in Figure 1) while the steel plates were lashed to the handrail with a 10mm nylon rope (see B, C and D in Figure 1).

The steel plates were stored vertically and leaning against a collapsible handrail and secured with a nylon rope of 10 mm in diameter. The handrail was not designed for storing steel plates. It is neither an appropriate location nor a proper method to store them. In addition, the 10mm nylon rope that was used to lash those plates was found to be in poor condition. The condition of the rope was a persistent risk during plate handling and securing when it parts.

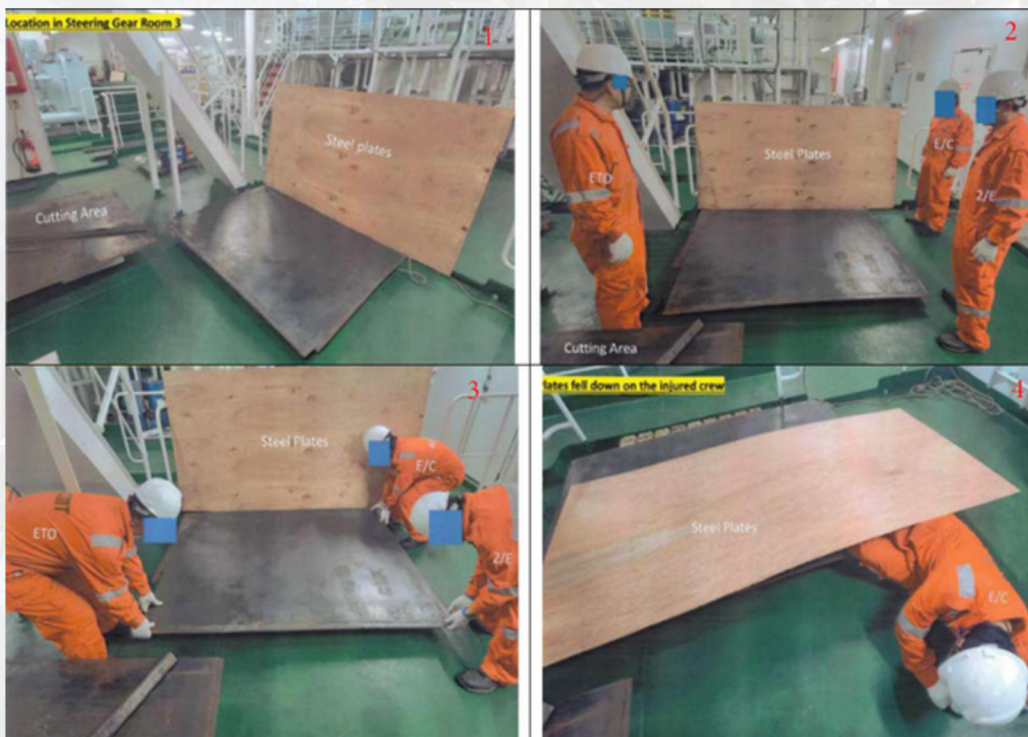
Figure 2

On the day of the incident while the vessel at sea, two Senior Engineers attempted to reposition a 5mm steel plate in a stowage area prior to bringing it to the nearby cutting area (see image B in Figure 1 and image 1 in Figure 2). A Junior Engineer (JE) was tasked to hold onto other vertically leaning plates that were supported against the railing to prevent them from falling.

While holding on to the vertically leaning plates, the JE was instructed by one of the Senior Engineer to assist with shifting the 5mm steel plate since it was too heavy for both Senior Engineers to move. The JE released the vertically leaning plates he was holding onto and squatted down to help lift the 5mm plate (see image 3 and 4 in Figure 2). At that moment, a sudden vibration of the vessel occurred, causing those leaning steel plates to fall onto the EC (see image 4 in Figure 2).

The RA for the above work activity was found to be generic and inadequate. Essentially, the RA did not identify the hazards associated with falling steel plates or the risk of injury resulted from sharp edges. At the time of the incident, the ship was pitching, and the motion increased the likelihood of the leaning plates to fall. While the JE was holding onto the remaining vertical plates, the Senior Engineer requested him to assist on shifting the 5mm steel plate. The Senior Engineers had omitted consideration of the JE's safety in relation to the risk of steel plates falling in view of the ship's pitching and rolling motions.

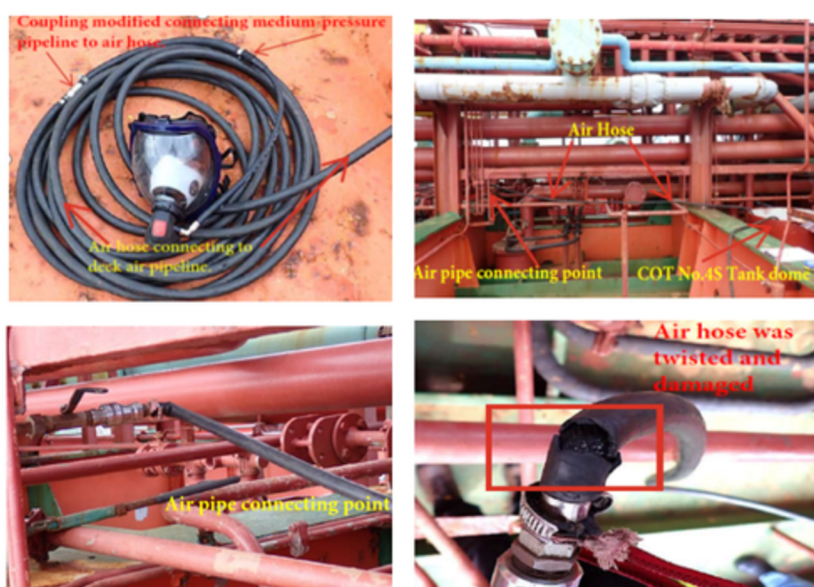
Figure 1

Tanks entries of the unwashed tanks by personnel were carried out without complying with the company's enclosed space entry procedures. An AB entered one of the unwashed tanks alone to place the Wilden pump at its pump well. The AB wore a face mask with a hose coupling that had been modified to connect to the deck air compressor (see Figure 1).

Considering the inconvenience of wearing the SCBA, the SDO instructed an unauthorised modification of the SCBA facemask (i.e. by connecting it to the air hose with compressed air supplied by deck air compressor), which was a deviation from its manufacturer's specifications and intended scope of application.

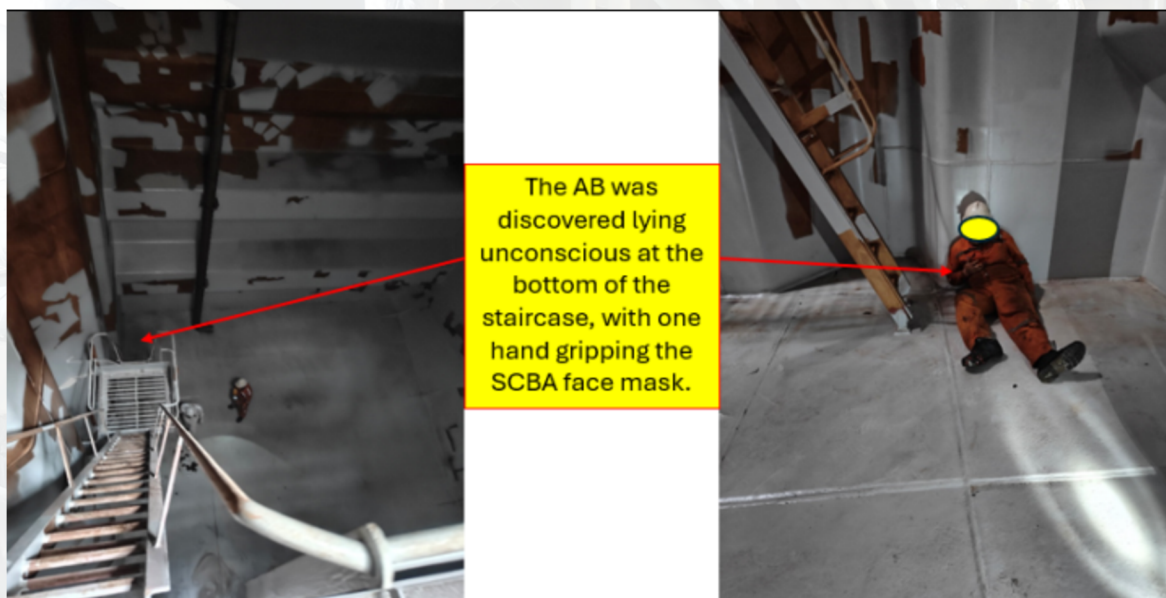
Figure 2

The said AB failed to emerge from the tank and did not respond to radio calls. Although an emergency rescue operation was initiated, there were further delays in view of emergency response equipment such as a tripod was not kept on standby at the tank dome (see Figure 2: a re-enactment of the fatality incident).

Re-enactment of incident by ship's crew

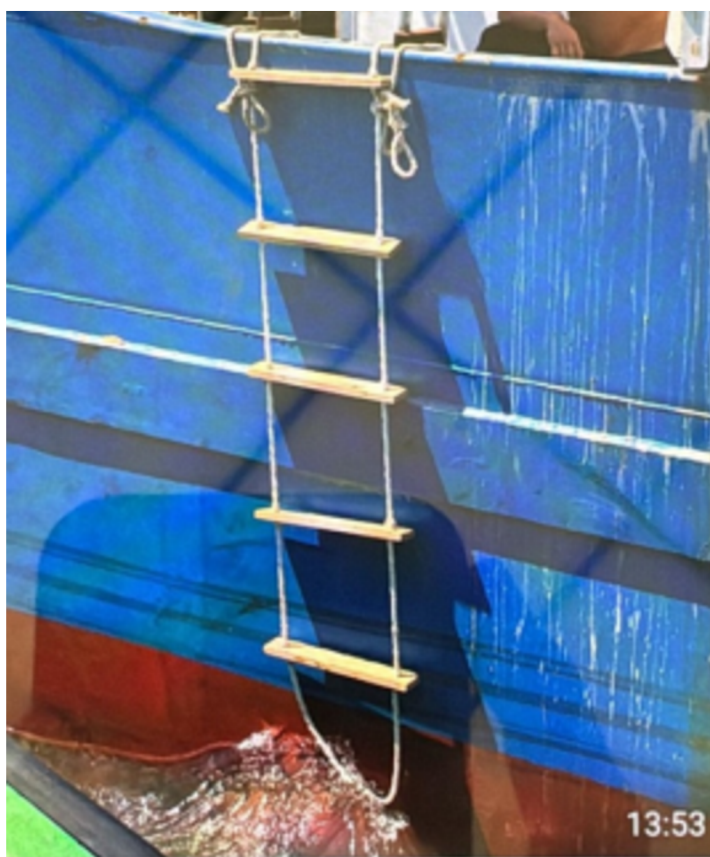
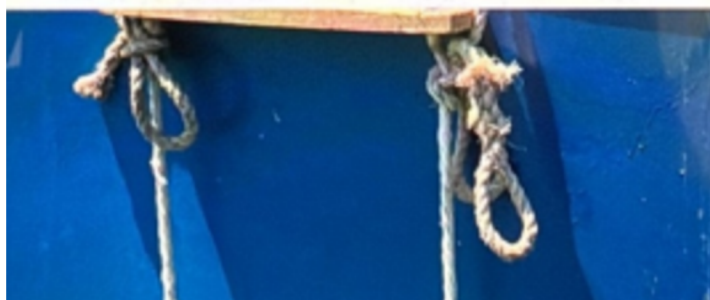
- Use of defective pilot ladders or improper securing methods.
- Combination arrangements (pilot ladder and accommodation ladder) improperly rigged.
- Inadequate lighting and safety measures during transfers.

Non-compliant pilot ladder

1. Compliance Verification: Confirm that all pilot transfer arrangements adhere to SOLAS regulations, IMO Resolution A.1045(27), and applicable local pilotage circulars.
2. Routine Inspections: Conduct thorough checks of pilot ladders, securing points, and related equipment before each use.
3. Training: Provide regular crew training on safe rigging and operation of pilot transfer arrangements.
4. Maintenance: Repair or replace defective equipment immediately.
5. Incident Reporting: Report any identified deficiencies or near misses to the relevant authorities promptly.

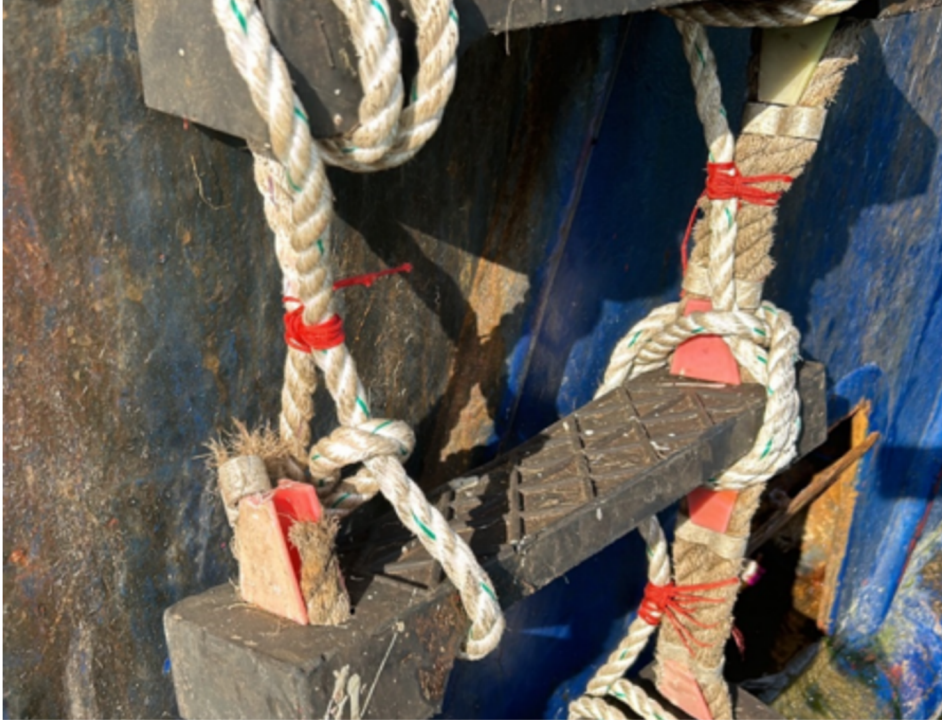
Defective Pilot Ladder

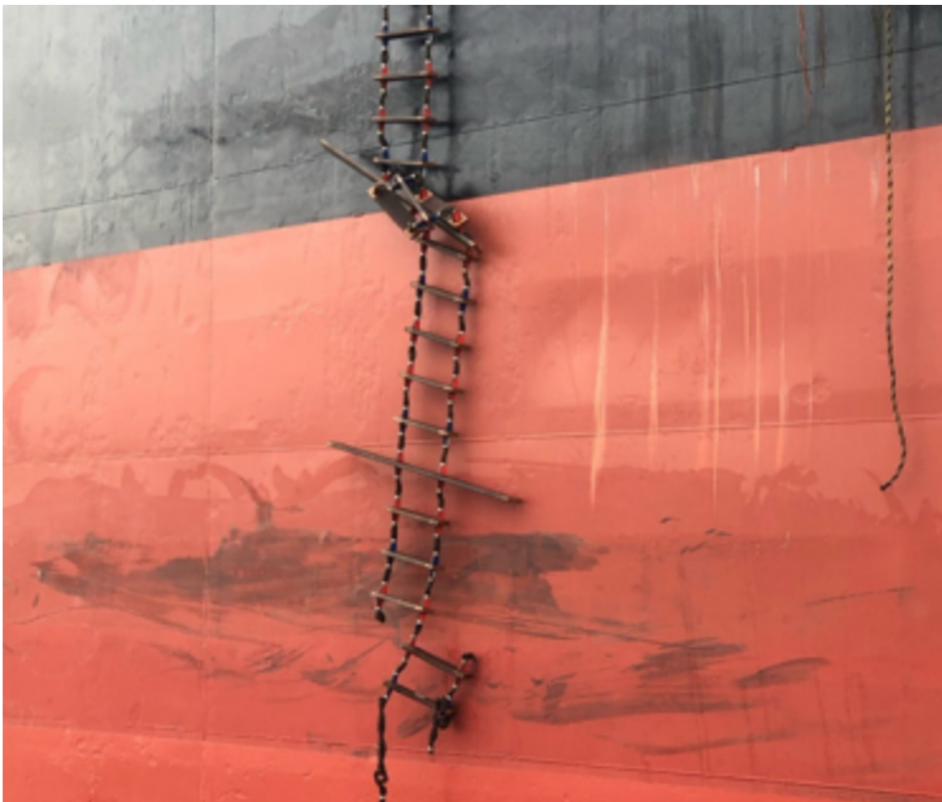
Defective pilot ladder (twisted and ropes parted)
