Environmental Impact Assessment for a Proposed Integrated Development at Marina Coastal Drive

Environmental Impact Assessment (EIA) Report

Final Report

Prepared for Maritime and Port Authority Singapore
Represented by Chu Rui Lim

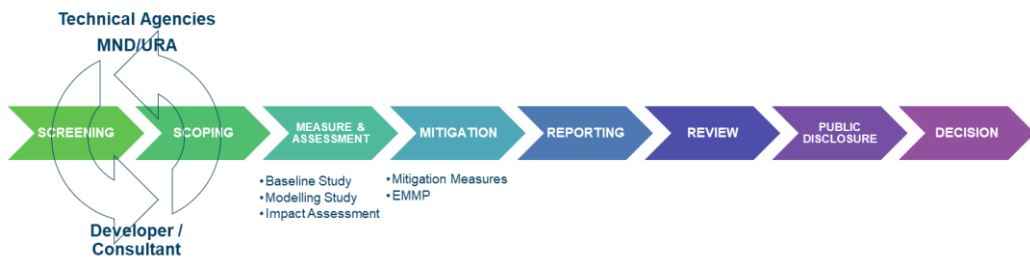
Figure 2.1 An illustration of EIA procedures in Singapore. Stakeholder engagement is project dependent and can take place at various stages of the study.

Singapore adopts a systematic framework to determine and mitigate the potential impact of any new development on the environment. Environmental considerations are an important part of the planning evaluation process, and planning approvals are granted to development proposals only when they have met the requirements imposed by the relevant regulatory agencies. If the impact on the environment could be significant, an environmental study will be required to assess in greater detail the full impact and develop more extensive mitigating measures. This study was carried out according to the local EIA process as illustrated in Figure 2.1 and summarized in Table 2.1. Note that Screening step has been conducted by MPA before DHI's commencement of this study, outcomes of which are documented in Section 3.

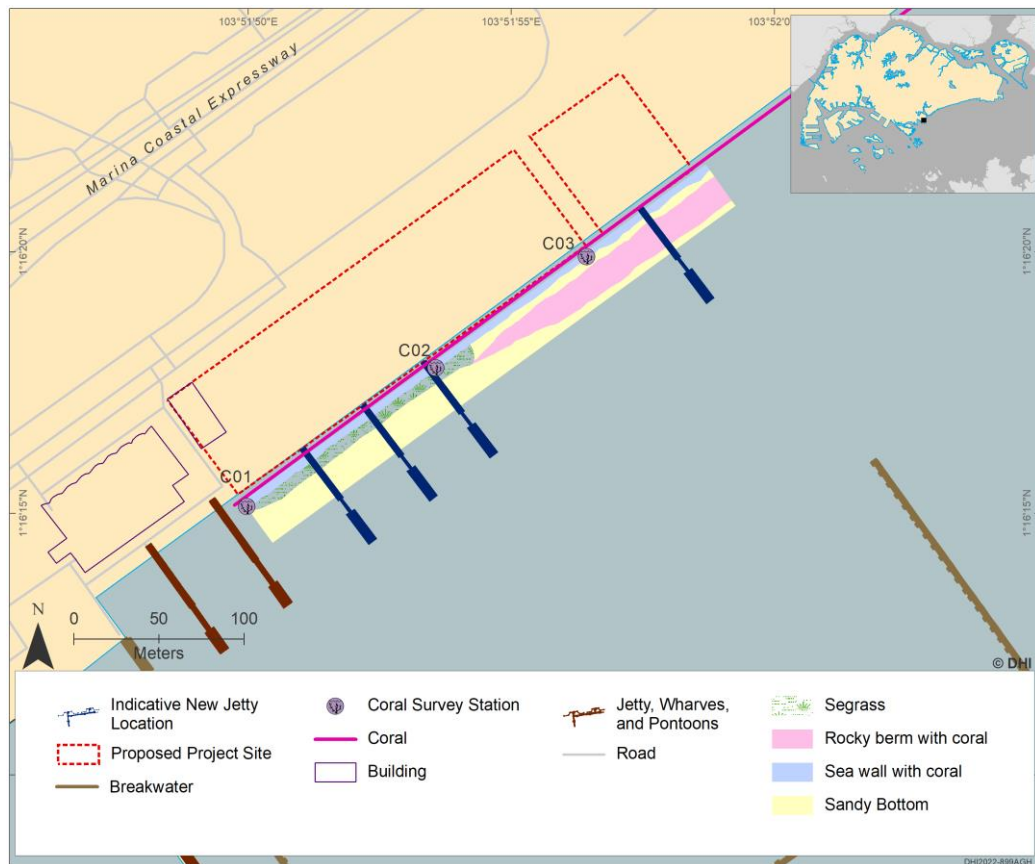
Figure 5.2 Habitat types at the study area (top view)

The substrate distribution of the study area is illustrated in Figure 5.2.

During the preliminary survey, hard corals were observed growing along the sea wall. Coral cover was gradually increasing from west (C01) towards the east (C03) (Figure 5.2). Based on the visual estimation, C01, C02 and C03 were with hard coral cover of 20 %, 25 % and 30 % respectively. In contrast, hard coral cover on the rocky berm was higher and estimated to be about 40% up to 80% at some parts (Figure 5.2). This coral community extended along the length of the berm beyond the end of transect C03 and acts like a barrier to the sea wall. The hard coral genera encountered also increased eastwards (C01, C02, C03: 27, 28 and 33 genera respectively). Large corals were observed with a diameter of up to 3m. A total of 39 hard coral genera were recorded across the three sites with a few locally “Occasional” genera encountered.

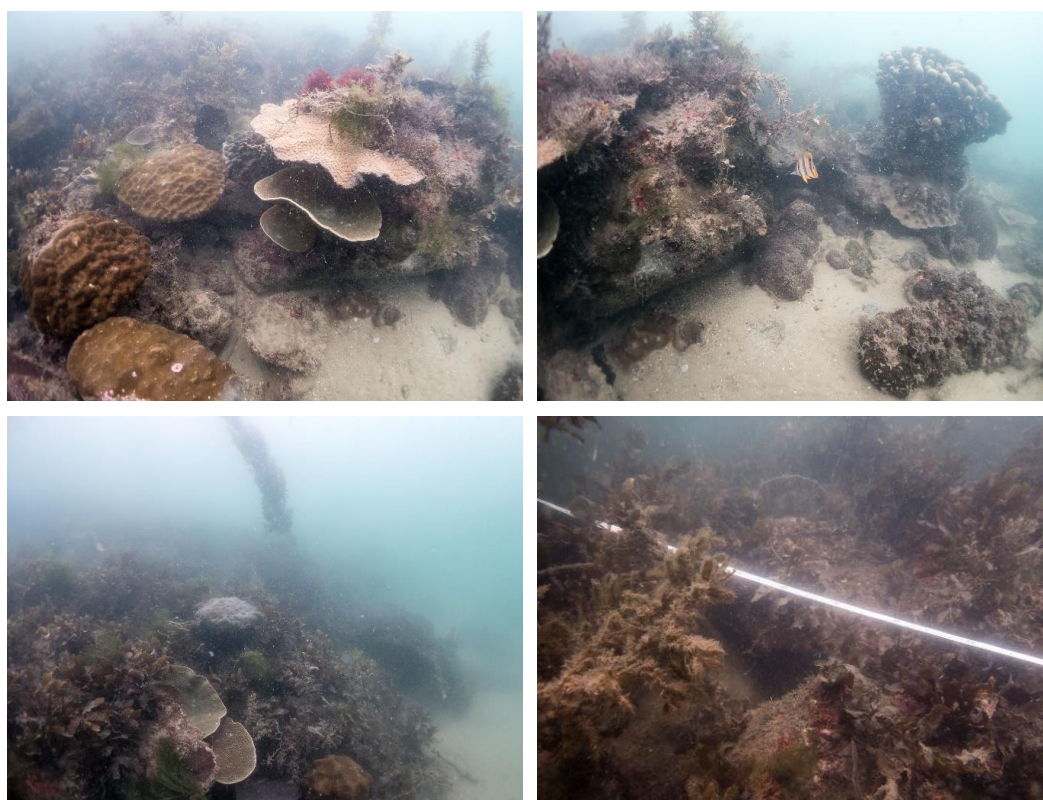
Figure 5.3 Overview of the sea wall and some representative photos during preliminary survey

The representative photos of the overview of the study area, the coral communities, and the seagrass communities were presented in Figure 5.3 to Figure 5.5. The hard coral genera checklist of the three sites were presented in Appendix B.

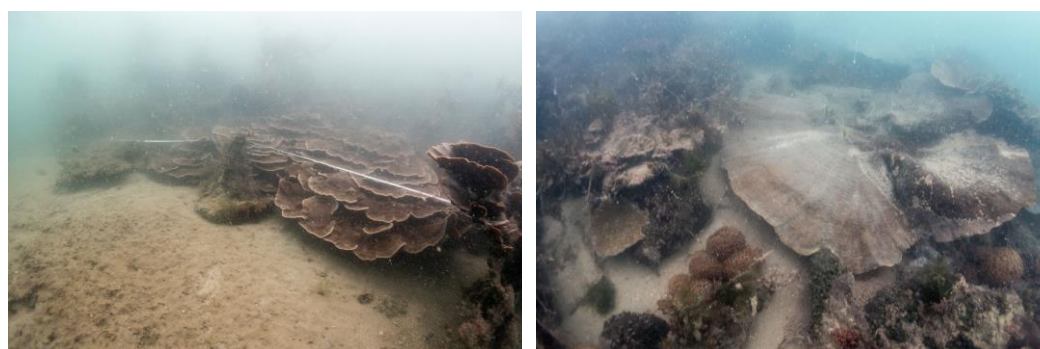
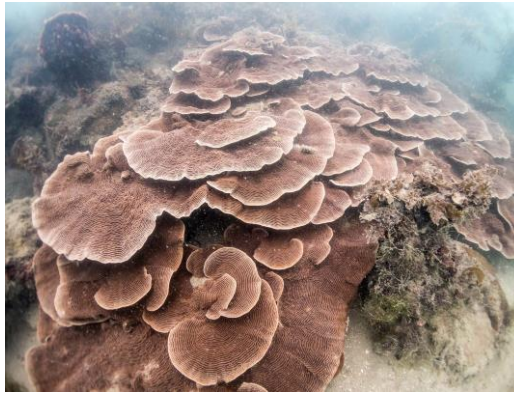
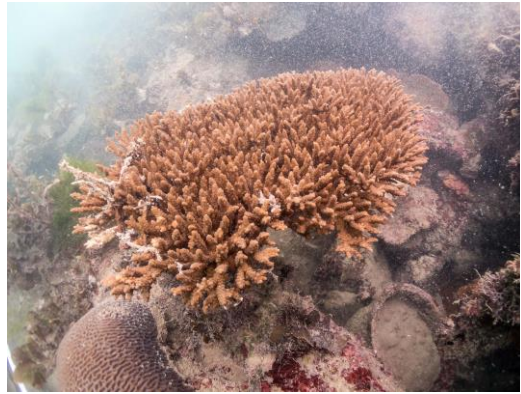
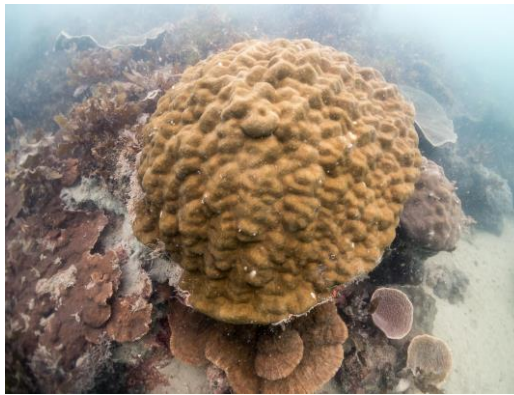
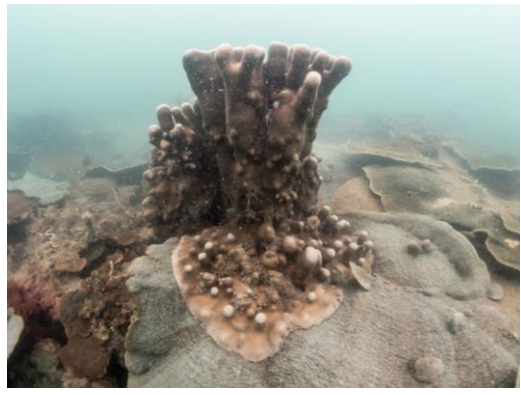
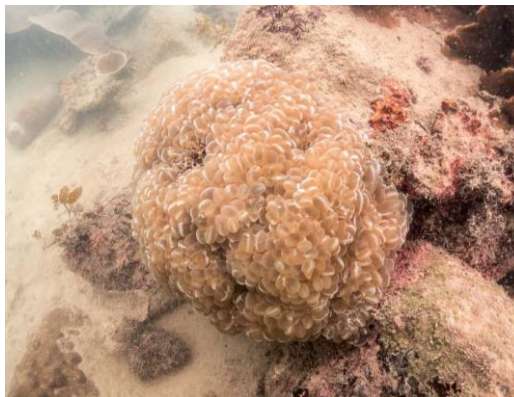
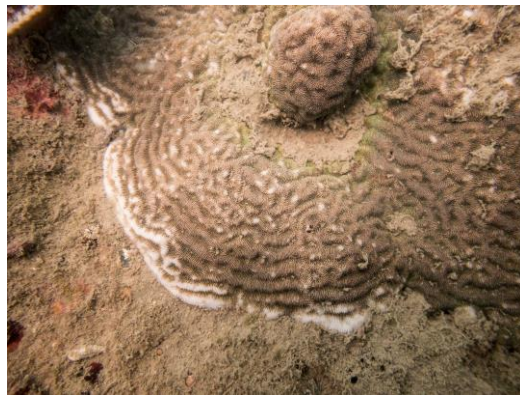
Figure 5.4 Overview of the rocky berm and some representative photos during preliminary survey

Overview of the rocky berm

Large foliose *Pachyseris speciosa*

Branching *Acropora millepora*.

Massive *Porites lobata*

Submassive *Psammocora haimiana*

Plerogyra sinuosa

Encrusting *Coscinaraea* sp.

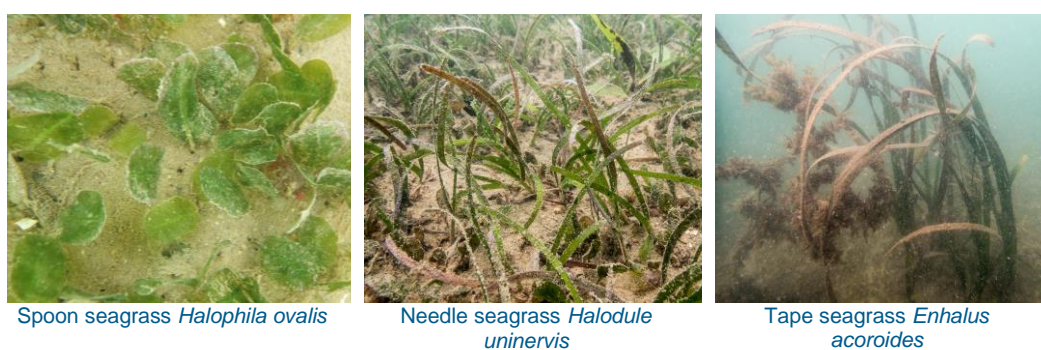
Figure 5.5 Representative photos of the seagrass communities in the study area during preliminary survey

Beyond the rock bund, along the sandy/silty substrate, a healthy seagrass meadow was observed. A total of three (3) species were encountered. the seagrass meadow was dominated by Spoon seagrass *Halophila ovalis*, and on some parts, mixed with Needle seagrass *Halodule uninervis*. A few stands of Tape seagrass *Enhalus acoroides* were also observed. The seagrass community extended up to about 5 m away from the base of sea wall and thrived at depth up to around -2.0 m CD. The seagrass meadow extended from C01 to before mid-way of C02 (total length ~ 130m). All the three seagrasses recorded are listed as “Vulnerable” on the Red List of threatened plants of Singapore (Davison, 2008).

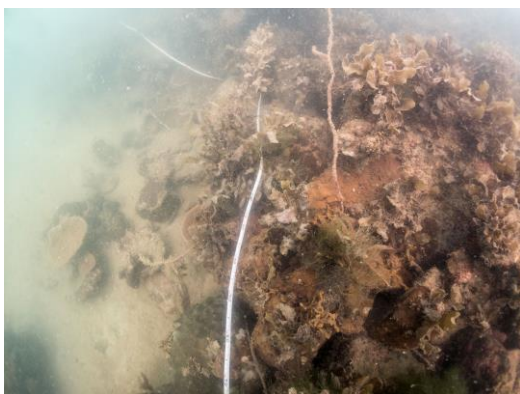
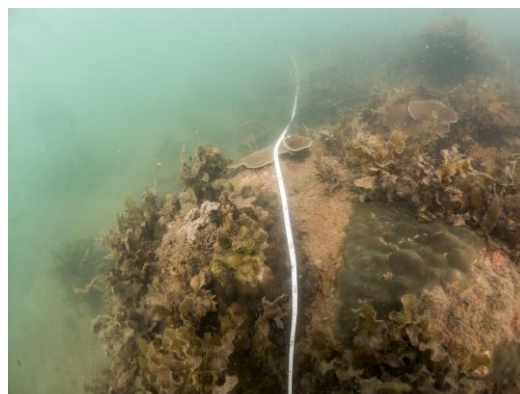
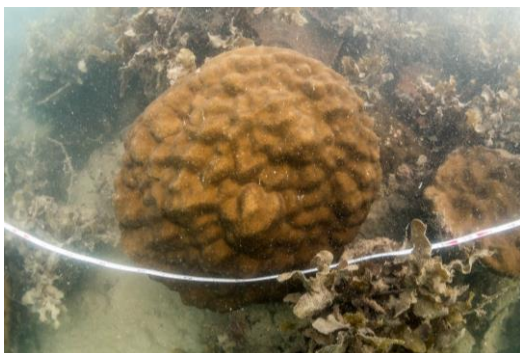
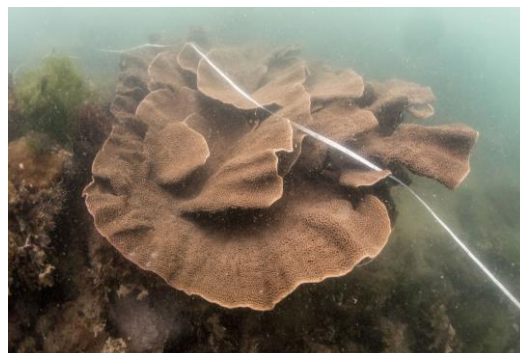
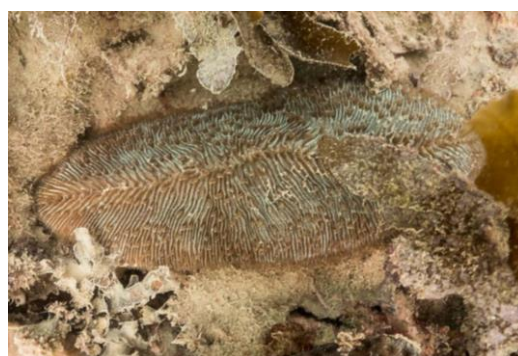
Figure 5.6 Representative photos at the sea wall of C02 during baseline survey

Overview at sea wall and at the beginning of C02 – low coral cover and high *Sargassum* cover

Overview at sea wall and near the end of C02 – higher coral cover and lower *Sargassum* cover

The most common genus by percentage and by occurrence – *Porites* with massive lifeform

Size 7 *Turbinaria reniformis* with foliose lifeform

Encrusting *Pseudosiderastrea tayamai*

Mushroom coral *Herpolitha limax*

Hard coral was the most common living benthos on the sea wall of C02 with a mean cover of $38.56 \% \pm 6.34$ (SE). The hard coral increased eastwards, 25.50% at the start and gradually increasing to 54.00% of the area surveyed. A total of 22 hard coral genera were encountered during the LIT survey and another 11 were found outside the transects. Of the 182 hard coral colonies recorded in the LIT survey, *Porites* was the most common genus both by occurrence (35 counts) and percentage cover (21.32 %). Foliose (44.32 %) and massive (34.26 %) were the more common growth forms encountered (Table 5.2). More than half of the coral colonies recorded were in the small to medium size classes, with a distribution of 34.62 % in Size 3 (10 to 25 cm) and 25.27 % in Size 4 (25 to 50 cm) (Table 5.2). There were ten (10) colonies of hard coral with size more than one (1) metre, which were from genera *Podabacia*, *Pachyseris*, *Porites*, *Turbinaria* and *Duncanopsammia*.

Algae also comprised a large part of living benthos on the sea wall of C02 (mean coverage: $29.57 \% \pm 5.60$ (SE)). The algae comprised largely of macroalgae *Sargassum* ($23.27 \% \pm 5.86$ (SE)). The exceptionally high percentage of *Sargassum* was due to the seasonal *Sargassum* blooms that have been known to occur locally (Low and Chou, 2013). The other algae recorded were turf algae, coralline algae, macroalgae (*Bryopsis*, *Dictyota* and *Halymenia*), and algae assemblage. The only other living benthos observed on sea wall was sponge ($2.18 \% \pm 4.68$ (SE)).

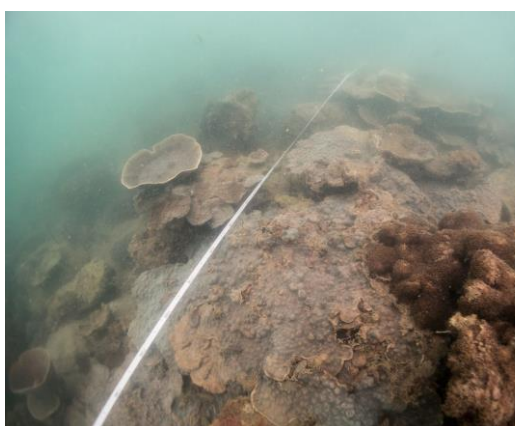
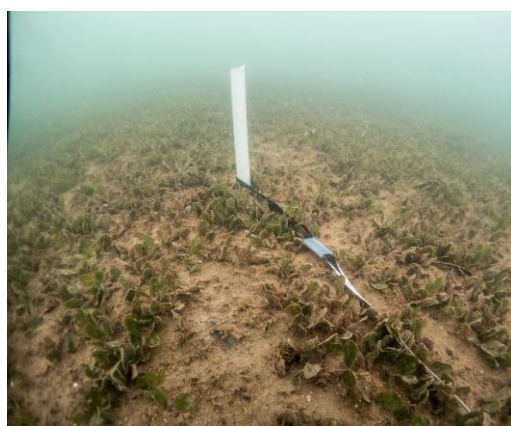
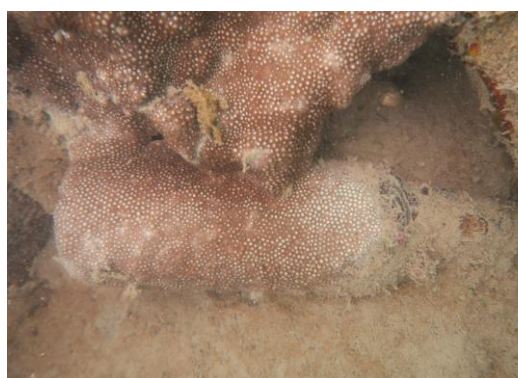
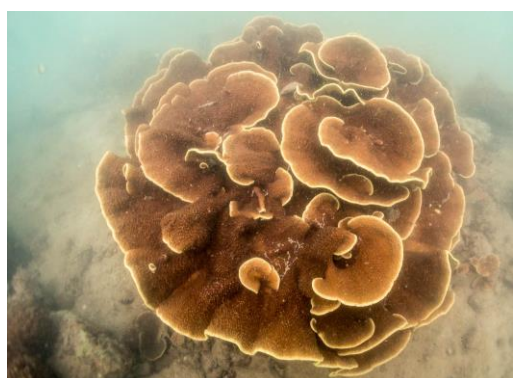
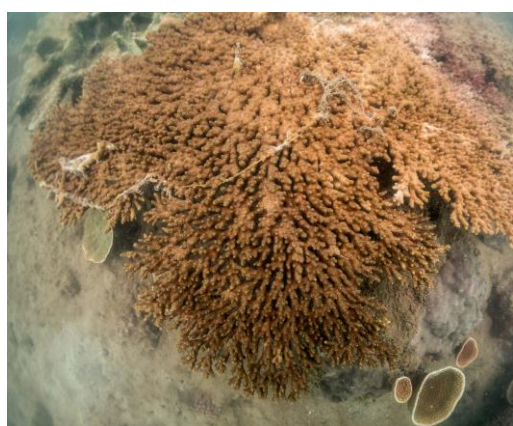
Figure 5.7 Representative photos of the coral communities at the rocky berm of C02

Overview at rocky berm

Spoon seagrass *H. ovalis* meadows at the start of transect

The most common genus by occurrence – *Bernardpora stutchburyi* encrusting onto debris

The most common genus by percentage – *Turbinaria reniformis*

Foliose *Montipora informis* with the most common growth form

Tabulate *Acropora* sp.

A bed of locally “Vulnerable” Spoon seagrass *H. ovalis* was observed at the first half of transect 1 (cover 29.60 % of transect 1) but were not recorded in other transects. However, more seagrass were observed beyond the first two survey transects between the sea wall and the berm, likely because the area is covered in soft substrate and the berm creates calm hydrodynamic conditions that are suitable for seagrass growth. The overall mean coverage of the seagrass was $5.92 \% \pm 5.92$ (SE).

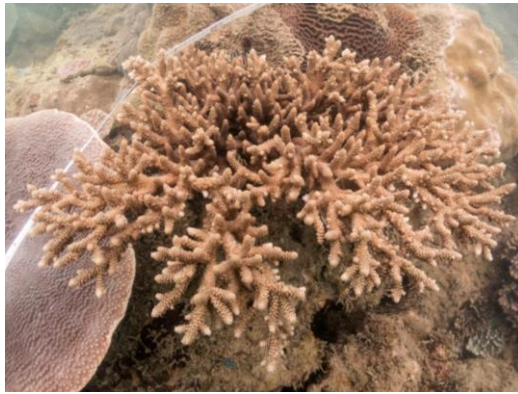
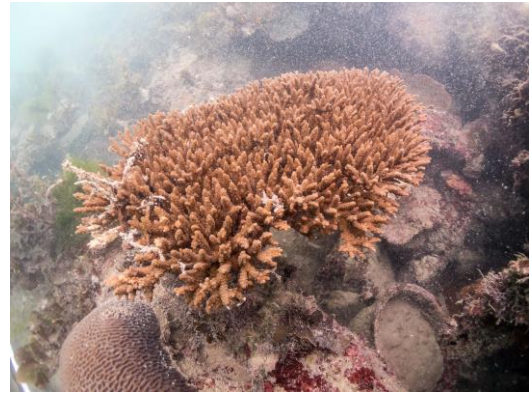
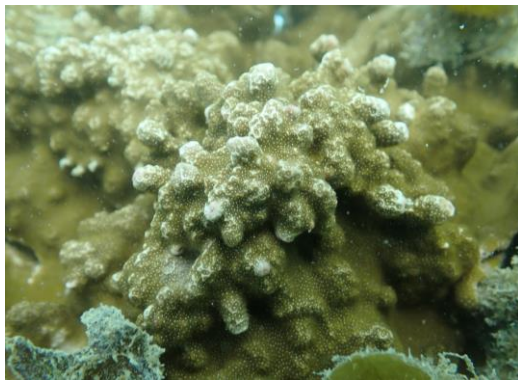
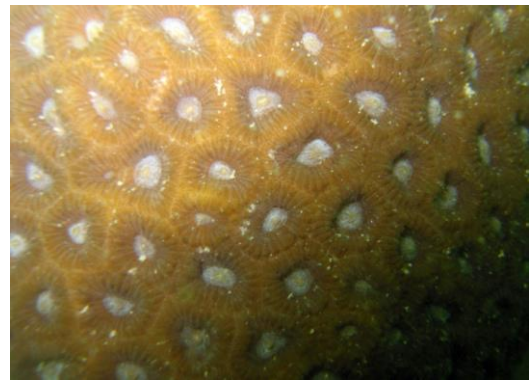
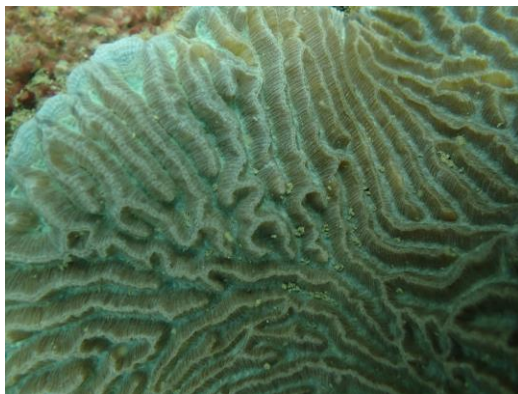
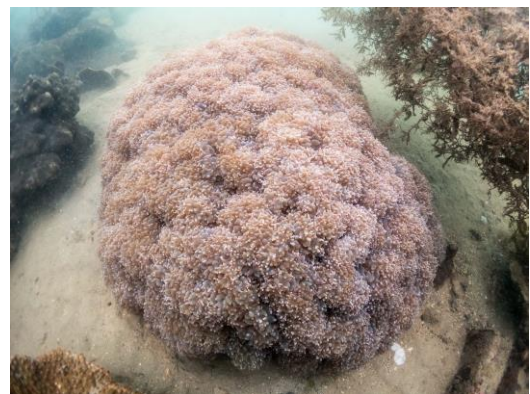
Locally “Endangered” *Acropora digitifera*

Locally “Endangered” *Acropora millepora*

Locally “Vulnerable” *Montipora grisea*

Locally “Vulnerable” *Dipsastraea pallida**

Locally “Vulnerable” *Platygyra lamellina*

Locally “Vulnerable” *Plerogyra sinuosa*

Figure 5.8 Representative photos of the coral species with conservation significance (*Photo is obtained from internet as no usable photos from the survey are available – *Acropora millepora* (Veron *et al.*, 2016); *Dipsastraea pallida* (BOS, 2022a); *Platygyra lamellina* (BOS, 2022b))
