Exhaust Gas Cleaning System (Scrubber)

An Advisory for Singapore-Registered Ships

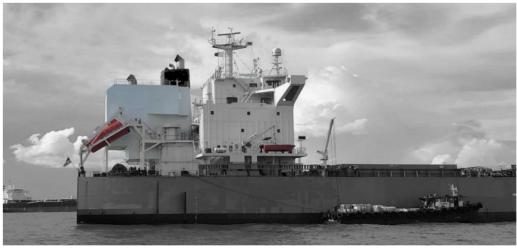
A bulk carrier retrofitted with enlarged funnel structure for scrubber

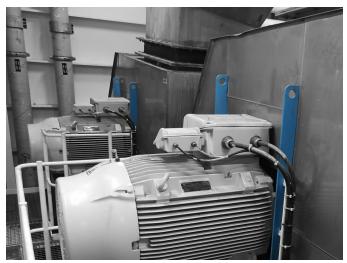
It is common that on a scrubber connected to multiple engines and boilers, extractor fans are provided on the scrubber outlet to the exhaust pipe to lower the pressure in the scrubber and thereby prevent excessive backpressure in the system. This will also to prevent higher backpressure from one engine or boiler affecting the other interconnected fuel burning units. In view of this, it is advisable that the impact of a scrubber fan failure on the safe operation of the fuel burning units should be carefully considered.

Exhaust gas extractor fans to reduce backpressure

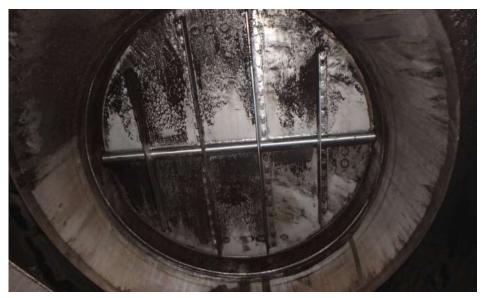
Interior of an exhaust gas bypass damper

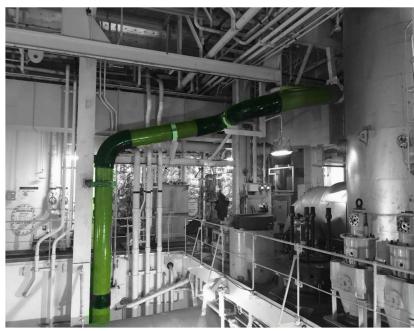
Glass Reinforced Ероху (GRE) pipes are commonly used for the scrubber washwater discharge piping, due to the strong acidity of the scrubber washwater. This GRE pipe being used must be an approved type for use in machinery spaces. GRE piping is lightweight, which makes it easier to handle during retrofits, but its reduced rigidity means GRE piping requires more support and has a larger bend radius than its size equivalent in steel.

Scrubber washwater discharge GRE pipe fitted in an engine room

The relevant classification rules should be followed, e.g. use of steel transition pieces, fitted with suitable closing devices where GRE piping passes through watertight bulkheads. GRE piping close to the scrubber must also be protected from exposure to hot exhaust gases.

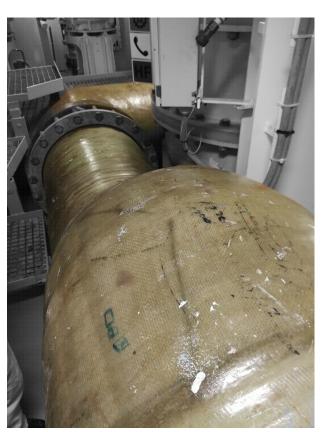
Close up view of a GRE pipe section

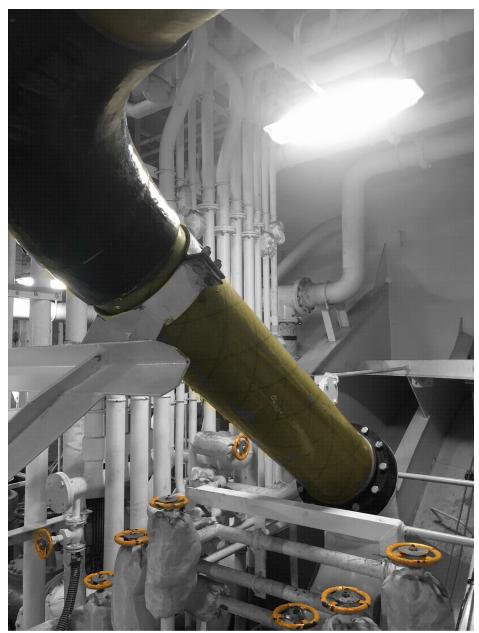
For open-loop scrubber installation, it is important to ensure that the washwater overboard discharge point is located below the water surface aft of the engine room, to prevent the discharged washwater from being sucked and re-circulated into the engine room sea chest, which may lead to corrosion of piping and fittings of other engine room sea water systems.

GRE pipe to overboard discharge.

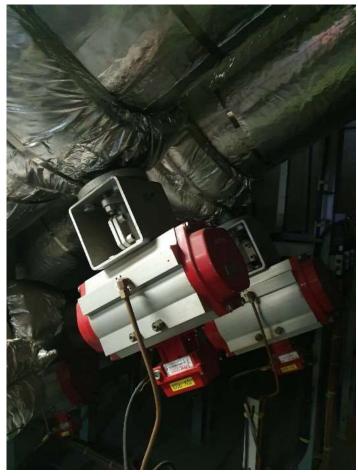
There have been reports of high temperature in the scrubber, even when the scrubber is not in operation and bypassed. This was subsequently identified to be due to leakage of the bypass dampers or defects in the sealing air system. Such a situation may result in fire/damage to scrubber components and material, if left unchecked. It is advisable to operate the exhaust gas dampers weekly in order to prevent seizure.

Exhaust gas damper actuators

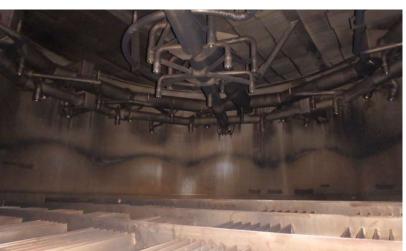
The basic operational concept of an SOx wet scrubber involves the mixing of water and sulphur from the exhaust gas. Naturally, this results in a corrosive environment within the scrubber tower and associated pipework. With this, comes the risk of water flooding and escape of exhaust gas into the engine room.

Interior of a scrubber tower with nozzles and demister

A failure of the water piping may flood the engine room within a short period of time. For ships operating under Unmanned Machinery Space (UMS), by the time the duty engineer responds and reaches the engine room after receiving the bilge alarm, the engine room bottom platform may have been flooded.

Regular inspection of the scrubber tower internal structure and early detection of pipework leaks are advisable. Crew should ensure that the emergency bilge suction pumps are always

in working condition. Additional bilge alarm/flood alarm connected to auto-shutdown of the scrubber and the washwater pumps should be considered. Manual emergency stops should be placed in the Engine Control Room, on the Bridge and on the scrubber panel for manual shut down when required.

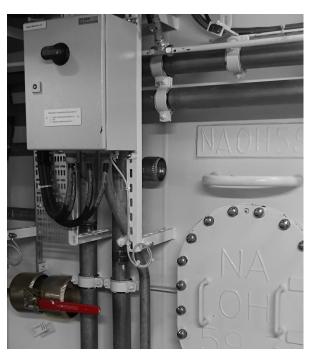
Caustic soda storage tank onboard a ship.

NaOH is a hazardous substance. Handling of the solution must strictly follow the Material Safety Data Sheet (MSDS). Crew must take special care when handling NaOH solution during bunkering or doing maintenance. Crew

should always wear goggles, gloves, and protective clothing when handling caustic soda. Working area should always be well illuminated and ventilated. Should the substance comes into contact with the crew, contaminated clothing must be removed immediately to avoid chemical burns and first aid administered immediately. Any spills must be cleaned up immediately.

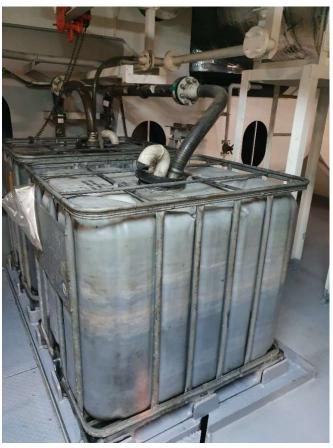
IBC tanks used for storing scrubber residue
